Historic Preservation Commission

ITEM: 917 Rex Street Landmark, Alteration Certificate, Grant, & Loan request

HISTORIC STRUCTURAL ASSESSMENT
917 REX STREET, LOUISVILLE, COLORADO

July 27, 2023

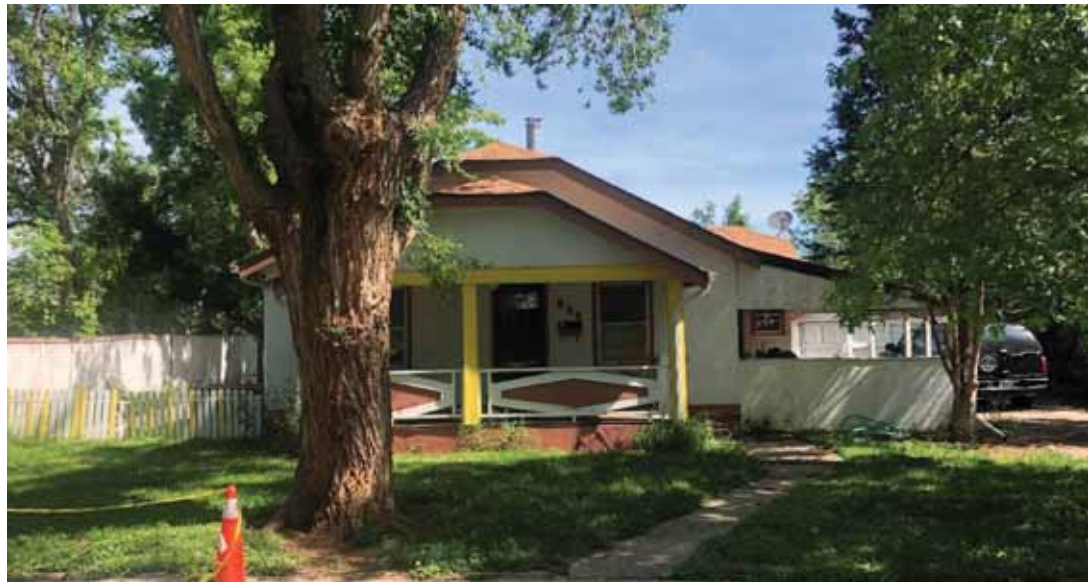
Overall, the landscape features are in fair condition with the primary issues being overgrown mature trees and concrete flatwork that has heaved in several areas. None of the listed features meet historic requirements, nor were any historic features discovered, and therefore assessment was minimal.

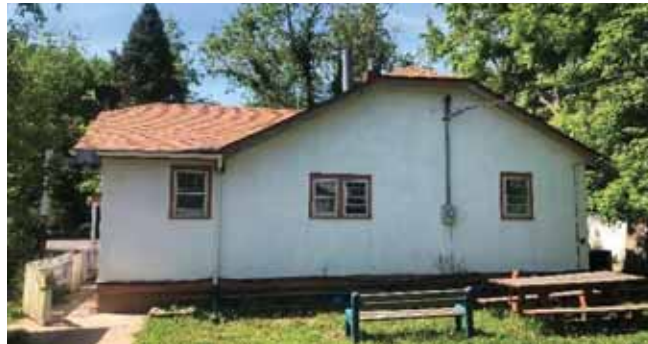
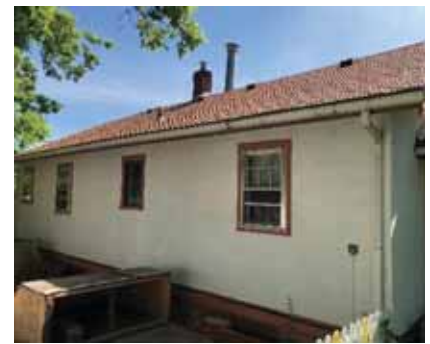
The overall site grading is in poor condition, as signs of damage caused by poor or negative drainage were observed and reported in the basement. Ideally, the grading around the house should be a minimum of 6 inches below the top of the foundation and slope away from the foundation for at least the first 5 feet. Due to the nature of the lot, it is unrealistic that these requirements may be achieved.

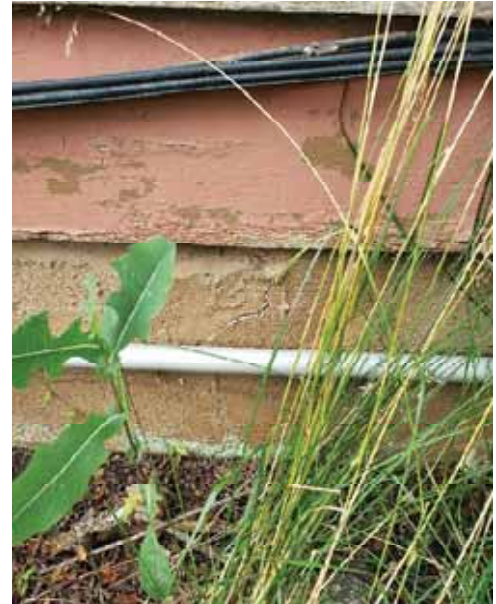
Foundation cracking viewed from the exterior.

The poured concrete perimeter foundation walls at the house are in fair to poor condition. Not all of the foundation walls could be fully analyzed as finish materials have been applied. A majority of the foundation was not showing cracks and there were minimal drywall cracks inside the home, indicative of a fair performing foundation system. However, concrete cracking was observed in a few areas around the exterior of the home. In addition, water infiltration has been observed on the west foundation wall. The access was limited at this location, and we were unable to determine if the water infiltration was due to improper exterior grading at this location or due to any cracks in the foundation wall at this location.

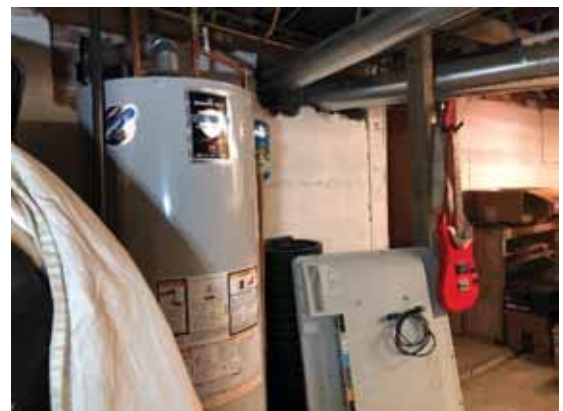
Central foundation wall with openings for ductwork.

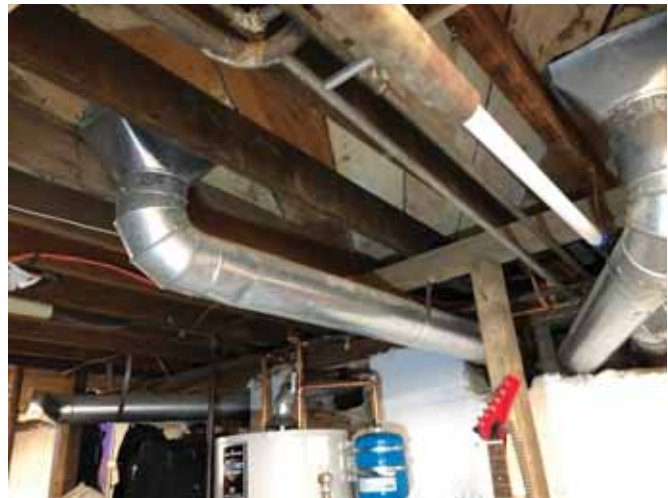
The beam above the foundation wall at approximately at the center of the basement appears to be performing poorly due to addition of new openings in the foundation wall below at several locations.

Floor joist supports were added where the foundation wall was opened up.

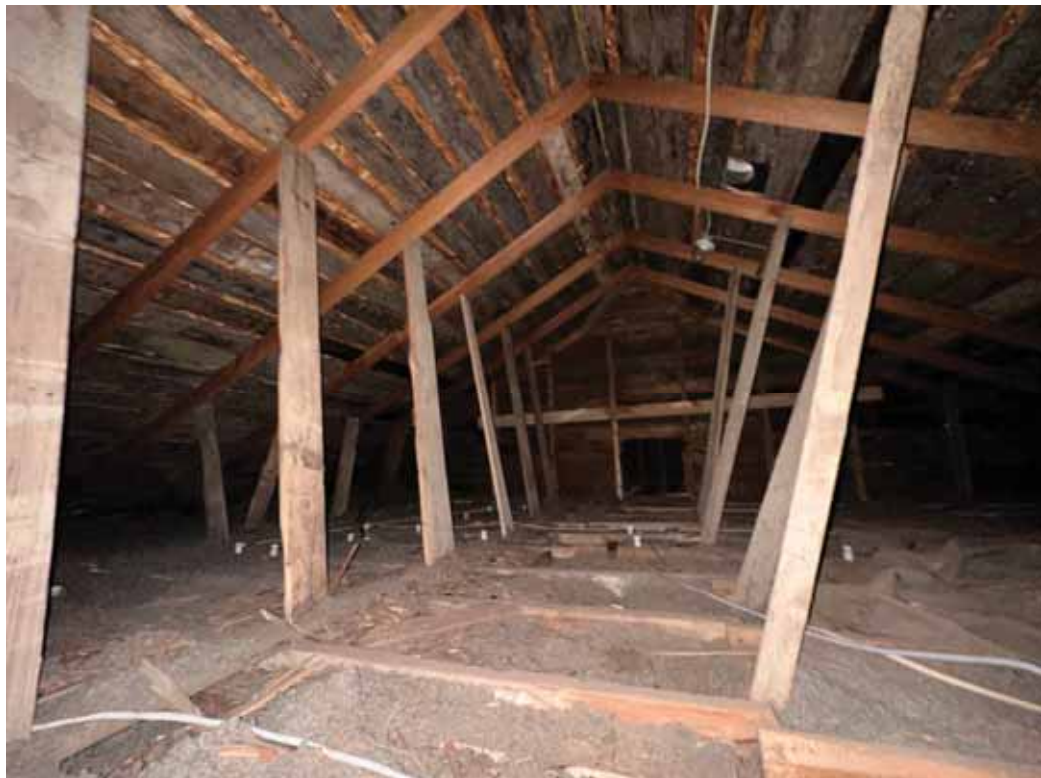
Main gable roof framing with access hatch to front porch roof framing.

The roof and ceiling structure are not to current code standards. The roof and ceiling system has shown higher than allowable deflection and if not revised will likely perform in a similar manner. Some of the following items should be considered to further solidify roof structure performance.

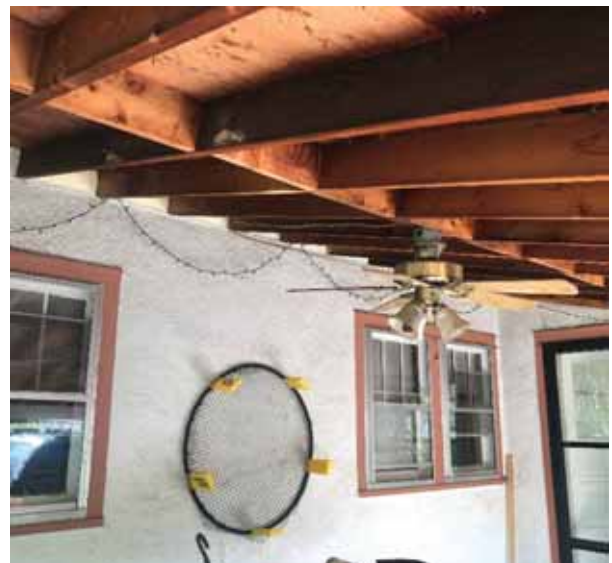
Shed roof framing over patio in southeast corner of the house.

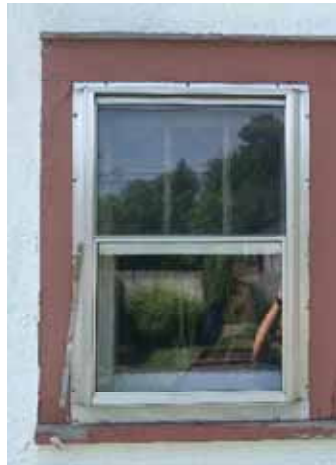
Original window and aluminum storm window

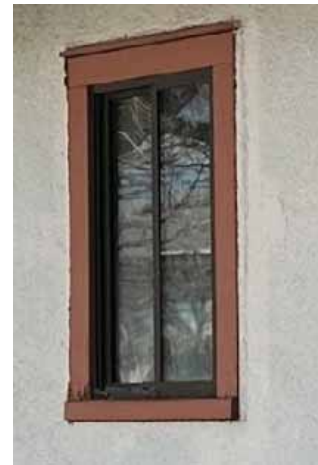
Replacement aluminum slider window.

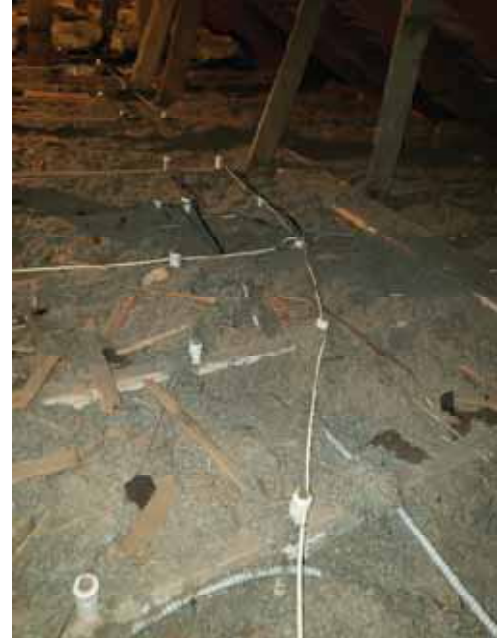
Extensive knob and tube wiring in the attic.

The knob and tube wiring should be tested by a licensed electrical engineer. If it is determined that the knob and tube wiring is still being used, consider replacing with new wiring that meets current code standards. If the knob and tube wiring is still in use, it presents a possible fire hazard. If the knob and tube wiring has been abandoned, no action is necessary.
