Louisville Highway 42 Revitalization Area
Conditions Survey

Louisville, Colorado

26 May 2005 (Updated June 2006)

Prepared for: Louisville Revitalization Commission and Louisville City Council

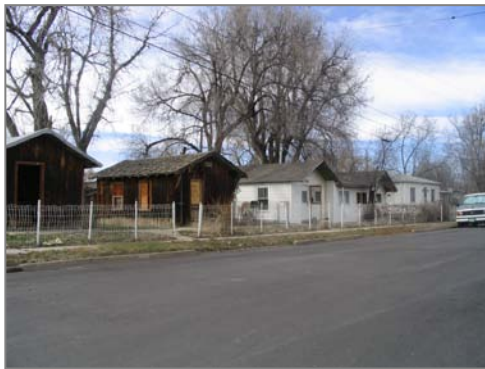
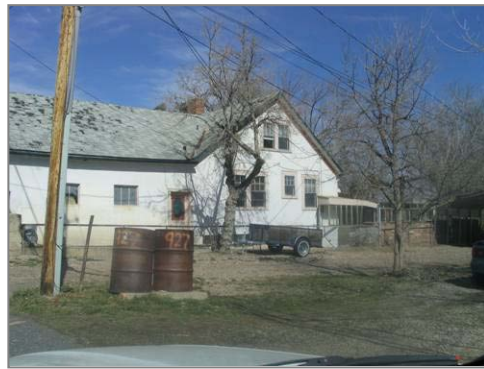
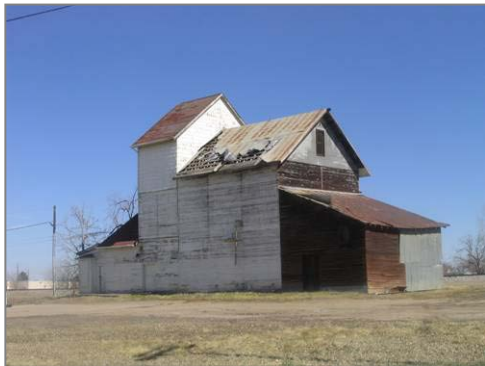
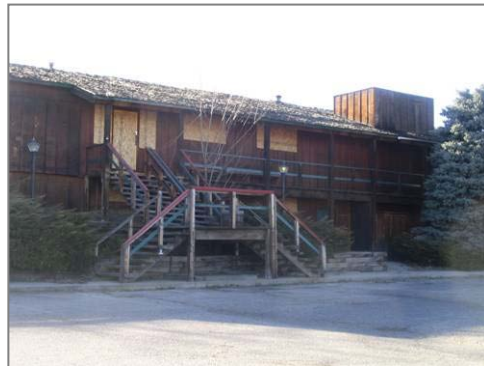
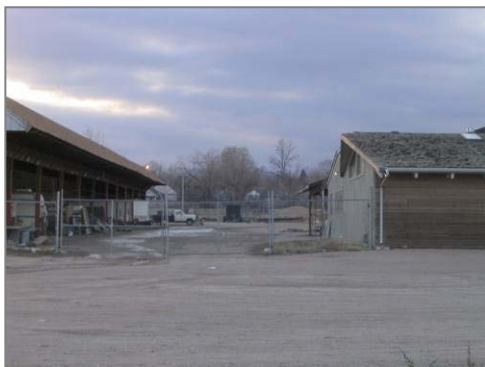
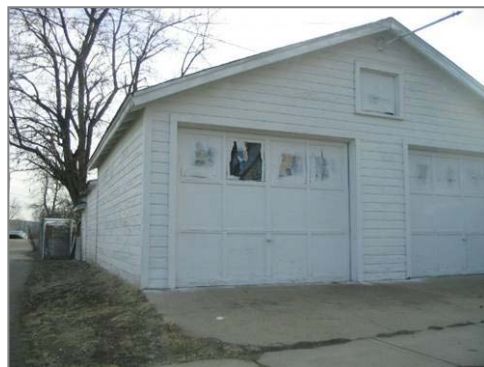
Although structural deterioration is most pronounced and obvious on the old grain elevator at the south end of the Study Area and the vacant restaurant property towards the north end, examples of this condition can be found among properties throughout the Study Area. The most common examples of structural deterioration found involved poorly maintained exterior finishes, and fascia and roof deterioration. Many properties were observed to have outbuildings in disrepair. Some older properties were also found to have window, roof, and wall deterioration. Other Study Area structural problems, though less common, included deterioration of exterior walls, gutters, fences, mechanical equipment and loading areas. Examples of properties affected by Condition (a) are shown in the photos below.

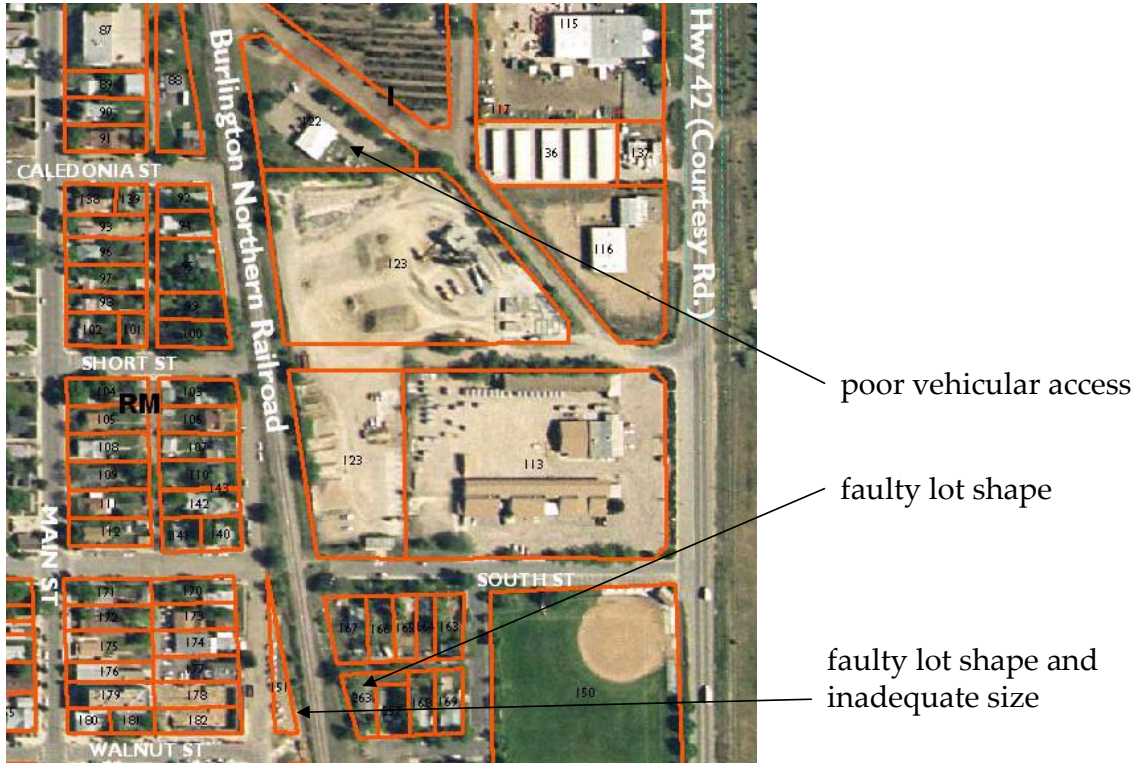
Examples of Condition (c)

The aerial photograph presented on the following page illustrates several examples of faulty lots in the Study Area, as per the statute Condition (c). The Appendix includes a map of parcels exhibiting this condition, and a parcel-by-parcel synthesis of qualifying conditions found during the field survey.

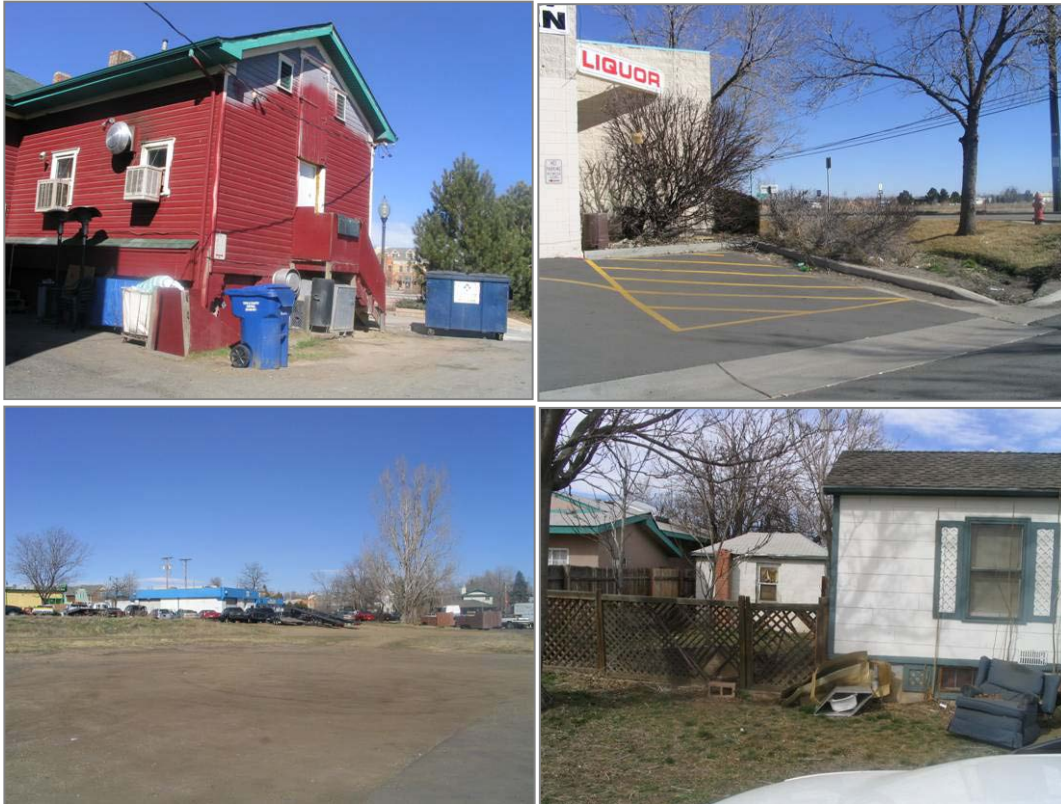
Examples of parcels exhibiting condition (d) are shown below:

A variety of blight conditions were observed within the Study Area related to the deterioration of the site and non-primary improvements. These conditions, which negatively affect the appearance and utilization of the area, most commonly include parking surface deterioration and unscreened trash and mechanical equipment. Several sites were found to have site maintenance problems, a lack of landscaping, general neglect or signage problems. Although this condition was most prevalent on older industrial and vacant properties, examples of site deterioration problems can be found on

scattered residential properties throughout the Study Area, as shown in the photographs below and detailed in the maps and field inventory.

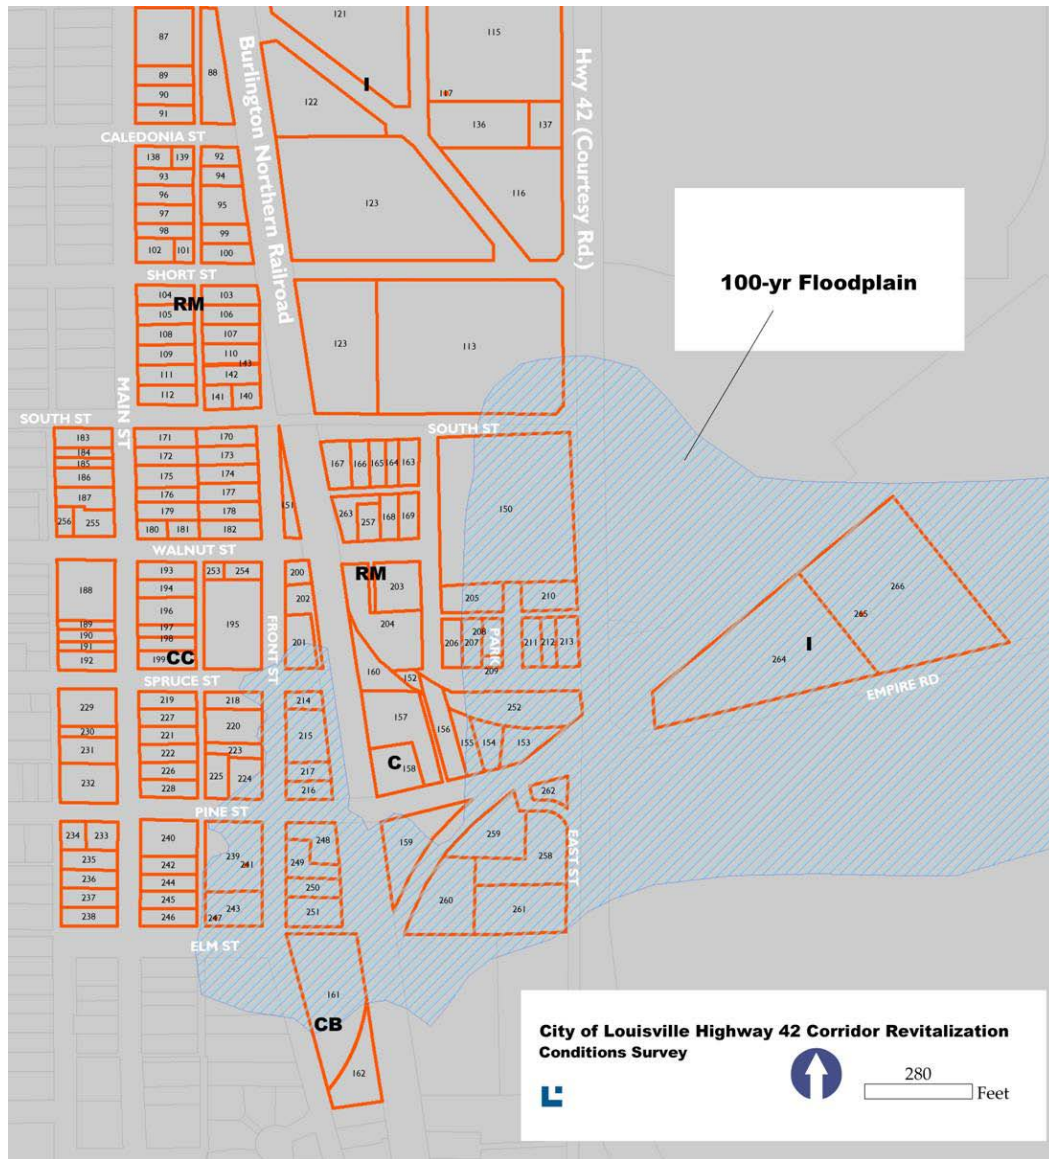
100-year Floodplain (FEMA Area "A")

Other instances of unsanitary or unsafe conditions were related to floodplain hazards and poor drainage. Twenty-eight properties throughout the Study Area are impacted by the 100-yr. floodplain (also known as 1 percent floodplain). This area is identified by the Federal Emergency Management Agency (FEMA) as Area “A” in maps produced to show flood insurance risk. The area of 1 percent annual flood risk is shown in the map below following the photographs.

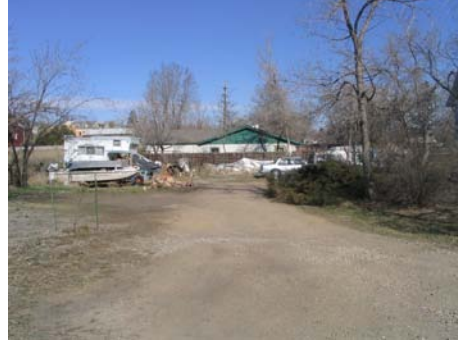
Another condition related to inadequate public improvements involves street pavement deterioration and a lack of paved streets. Because the unit of analysis in this conditions survey is the parcel (and because public streets within the Study Area are not individual parcels) the condition of faulty street layout is referenced in the maps and tables as occurring on the adjacent parcel or parcels, rather than on the streets themselves.

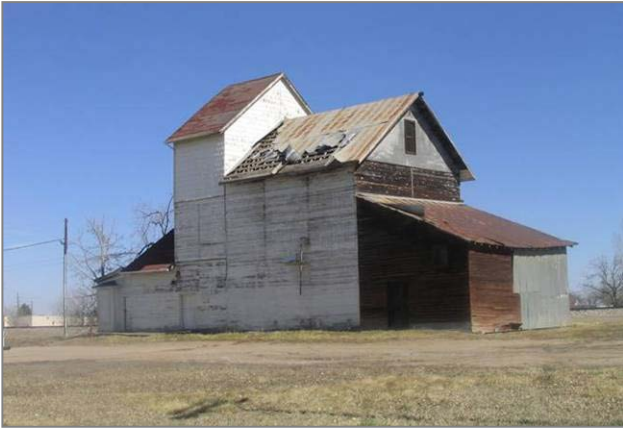
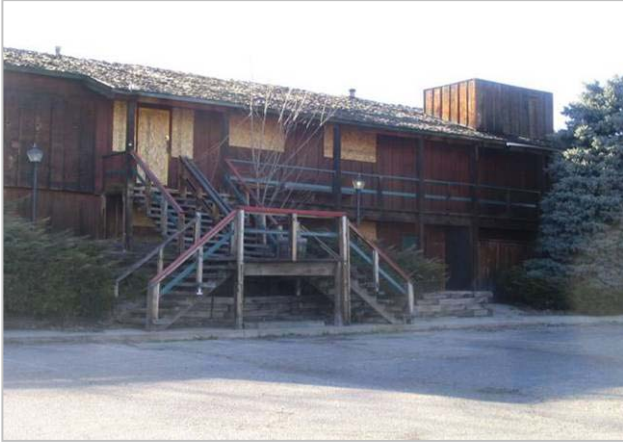
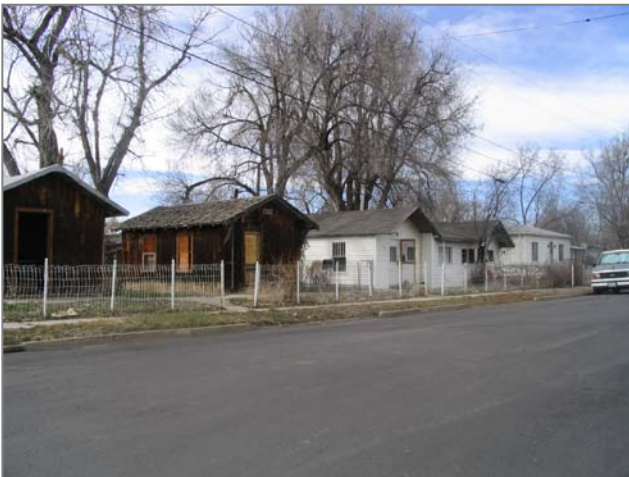
Examples of Unsafe or Unhealthy Building Conditions

Unhealthy or unsafe building conditions are said to be present on parcels with structures that appear to have obviously unsafe structures or facilities. No interior inspections were performed, so only three parcels were considered sufficiently dilapidated, based on their exterior appearance, to be counted unhealthy or unsafe due to design or construction as per the state statute.

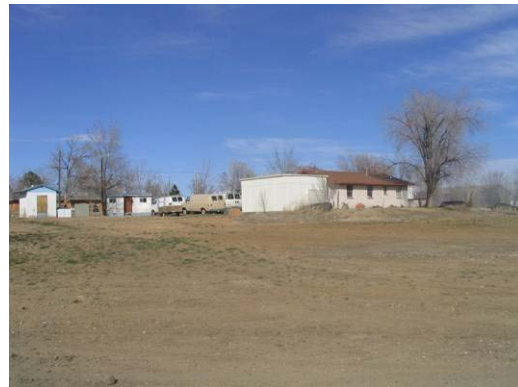
The Study Area includes 16 parcels with either vacant land or vacant buildings, amounting to 36 of the 133 total (non-road) study area acres. These properties are considered underutilized for the purposes of this analysis.
