Louisville Highway 42 Revitalization Area
Conditions Survey

Louisville, Colorado

26 May 2005 (Updated June 2006)

Prepared for: Louisville Revitalization Commission and Louisville City Council

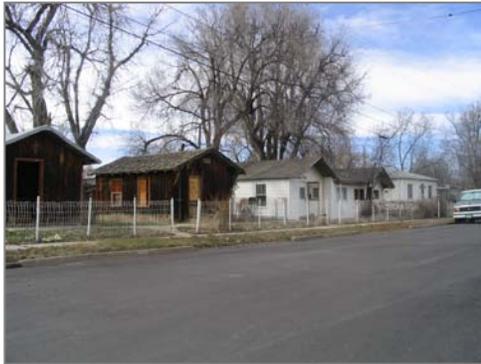
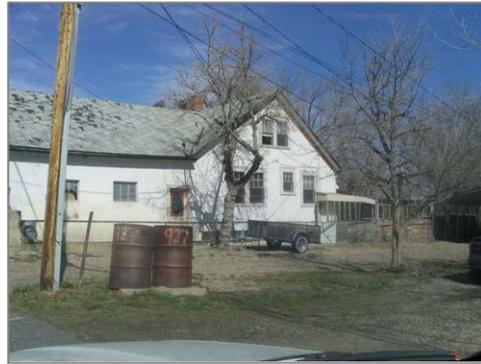
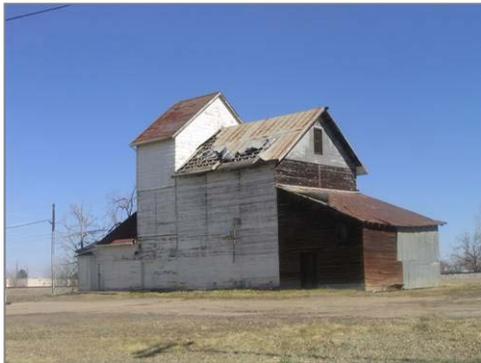
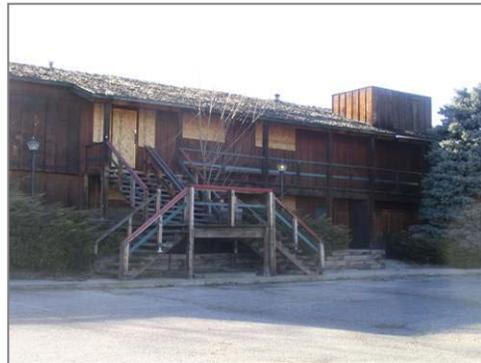
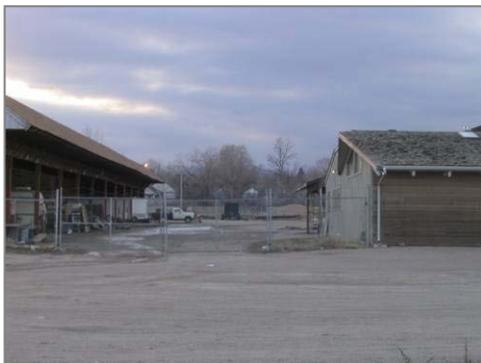
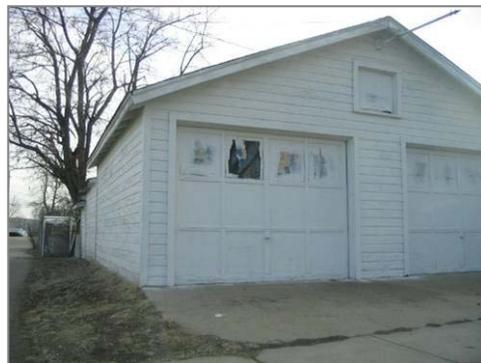
Although structural deterioration is most pronounced and obvious on the old grain elevator at the south end of the Study Area and the vacant restaurant property towards the north end, examples of this condition can be found among properties throughout the Study Area. The most common examples of structural deterioration found involved poorly maintained exterior finishes, and fascia and roof deterioration. Many properties were observed to have outbuildings in disrepair. Some older properties were also found to have window, roof, and wall deterioration. Other Study Area structural problems, though less common, included deterioration of exterior walls, gutters, fences, mechanical equipment and loading areas. Examples of properties affected by Condition (a) are shown in the photos below.

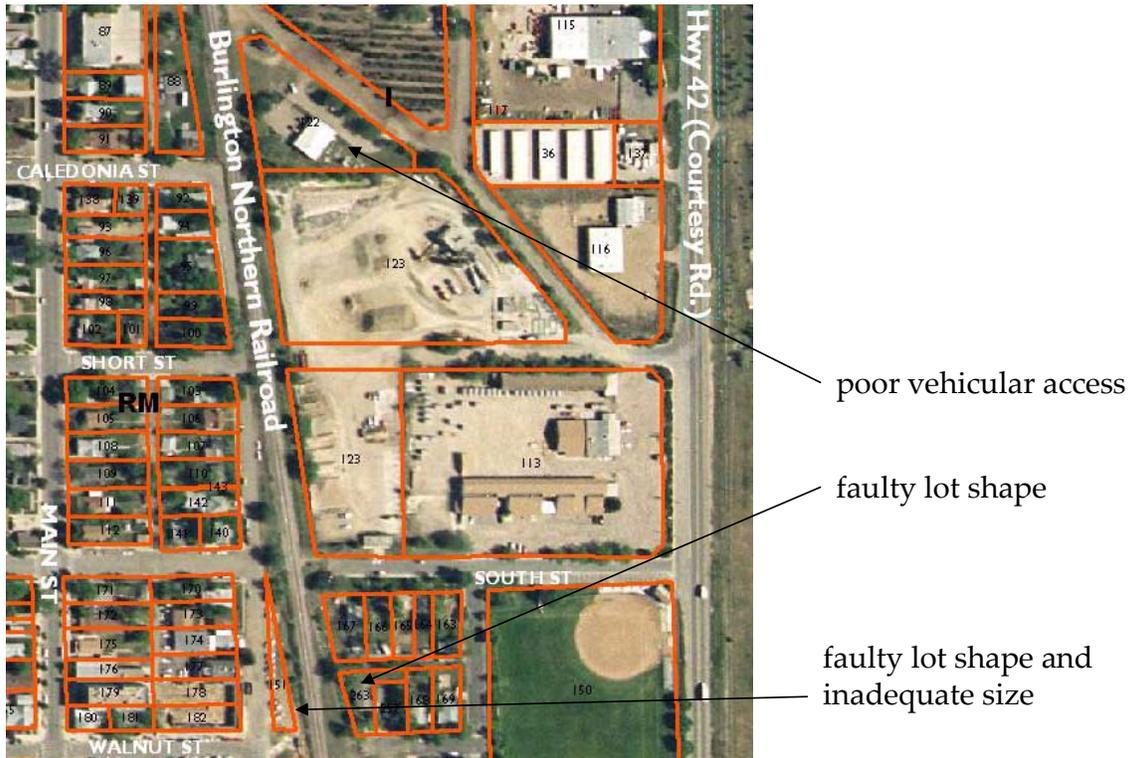
Examples of Condition (c)

The aerial photograph presented on the following page illustrates several examples of faulty lots in the Study Area, as per the statute Condition (c). The Appendix includes a map of parcels exhibiting this condition, and a parcel-by-parcel synthesis of qualifying conditions found during the field survey.

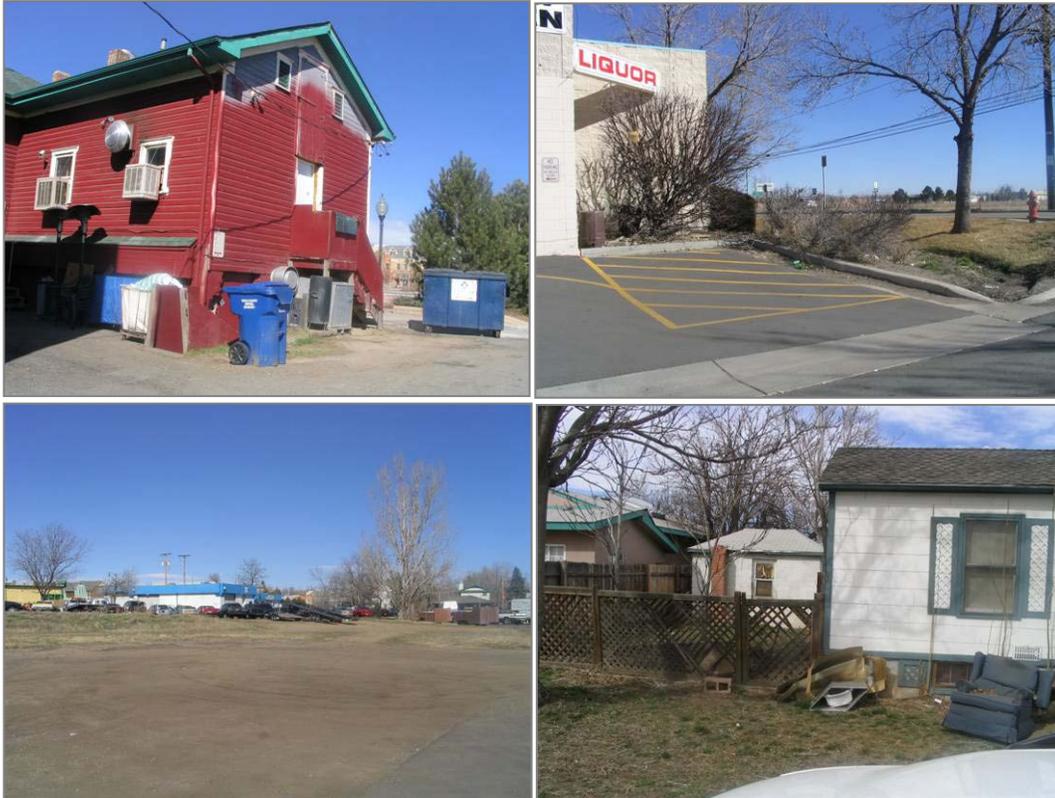
Examples of parcels exhibiting condition (d) are shown below:

There are several locations within the Study Area exhibiting unsanitary or unsafe conditions. The most prevalent Study Area conditions considered unsanitary or unsafe include: poorly lit or unlit areas; unscreened trash or mechanical equipment; abandoned vehicles; and, flood hazard.

Poorly lit areas are prevalent throughout the Study Area particularly on large vacant parcels, in parking lots in front of or behind older businesses, and on industrial parcels in general. Problems with unscreened trash and mechanical equipment can be found throughout the Study Area as well, most commonly on property around older industrial and salvage businesses and in large vacant areas.

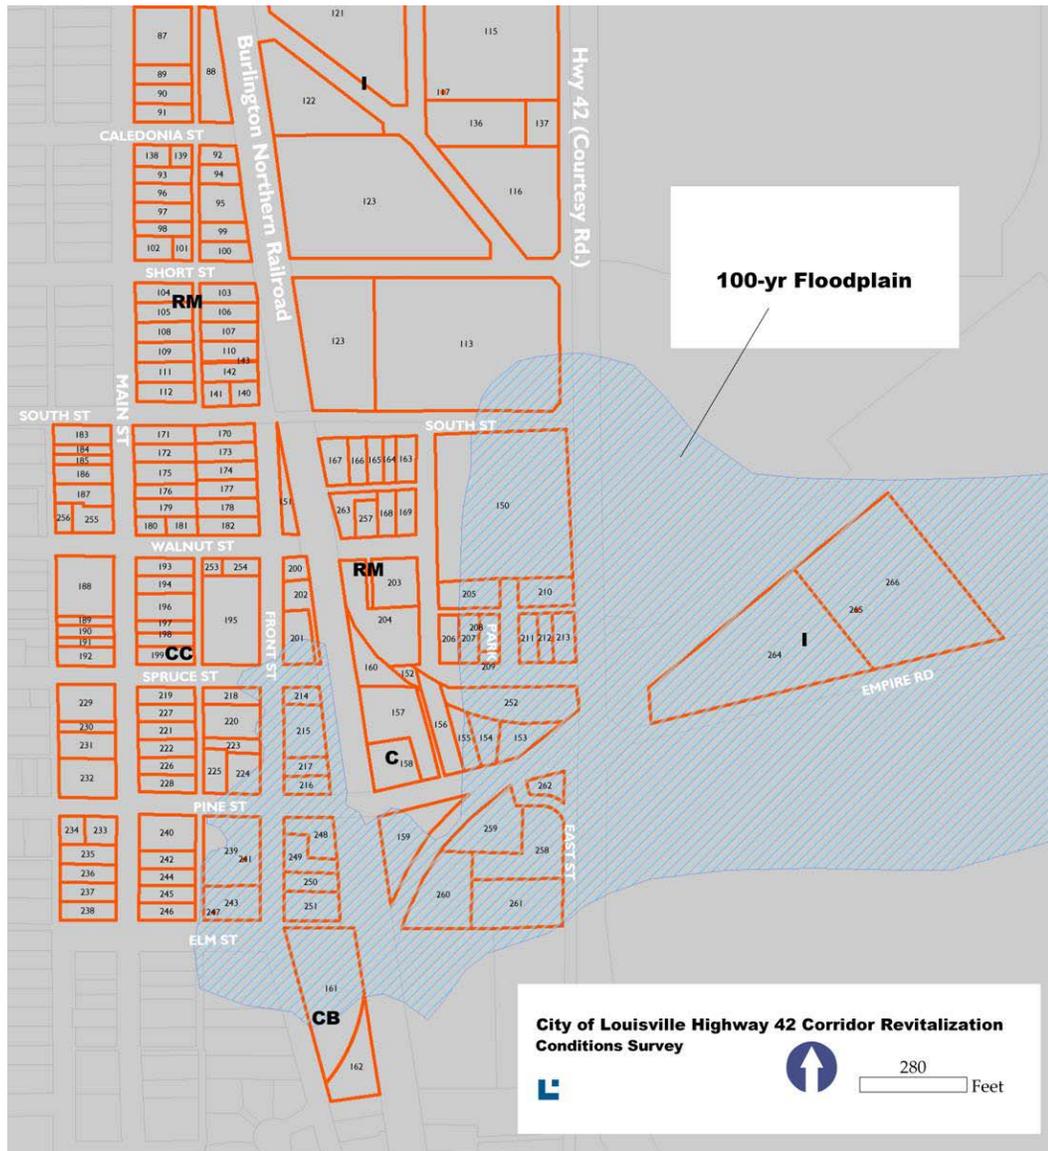
100-year Floodplain (FEMA Area "A")

Other instances of unsanitary or unsafe conditions were related to floodplain hazards and poor drainage. Twenty-eight properties throughout the Study Area are impacted by the 100-yr. floodplain (also known as 1 percent floodplain). This area is identified by the Federal Emergency Management Agency (FEMA) as Area “A” in maps produced to show flood insurance risk. The area of 1 percent annual flood risk is shown in the map below following the photographs.

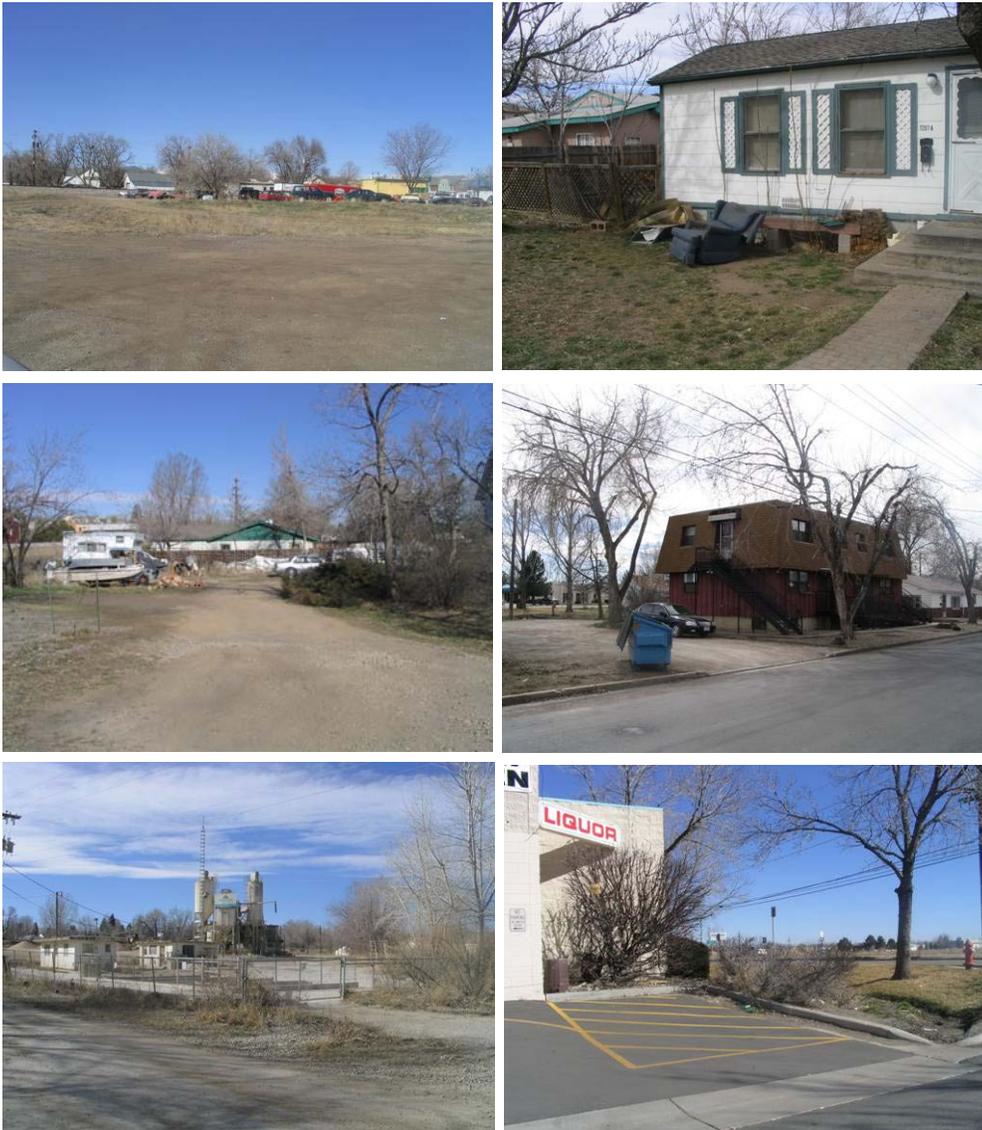
Examples of Condition (e)

A variety of blight conditions were observed within the Study Area related to the deterioration of the site and non-primary improvements. These conditions, which negatively affect the appearance and utilization of the area, most commonly include parking surface deterioration and unscreened trash and mechanical equipment. Several sites were found to have site maintenance problems, a lack of landscaping, general neglect or signage problems. Although this condition was most prevalent on older industrial and vacant properties, examples of site deterioration problems can be found on

scattered residential properties throughout the Study Area, as shown in the photographs below and detailed in the maps and field inventory.

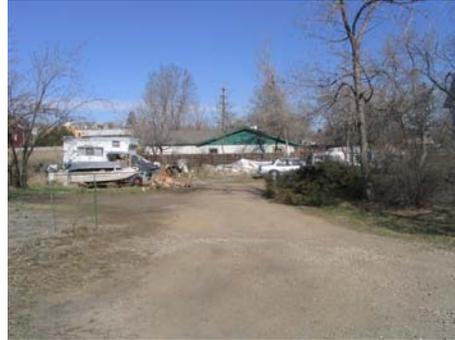
Another condition related to inadequate public improvements involves street pavement deterioration and a lack of paved streets. Because the unit of analysis in this conditions survey is the parcel (and because public streets within the Study Area are not individual parcels) the condition of faulty street layout is referenced in the maps and tables as occurring on the adjacent parcel or parcels, rather than on the streets themselves.

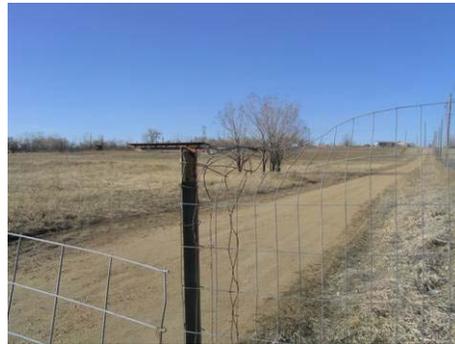
Additionally, almost all parcels are considered, for purposes of this analysis, to have outdated power and phone system provision because of their reliance on overhead utilities. This is considered to be an impediment to modern development and redevelopment in the current real estate market.

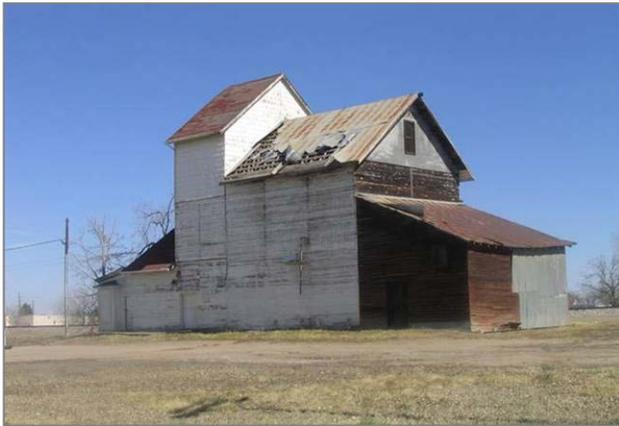
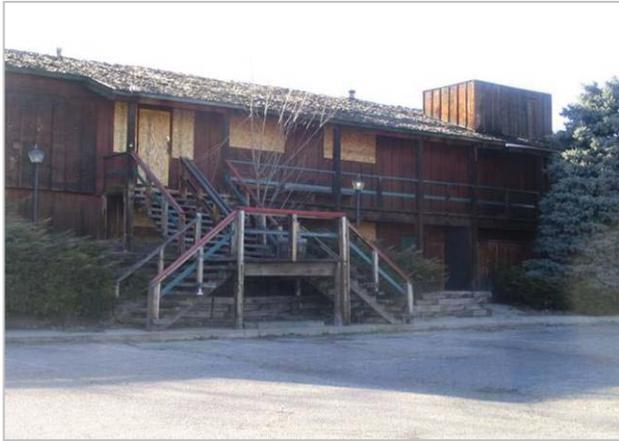
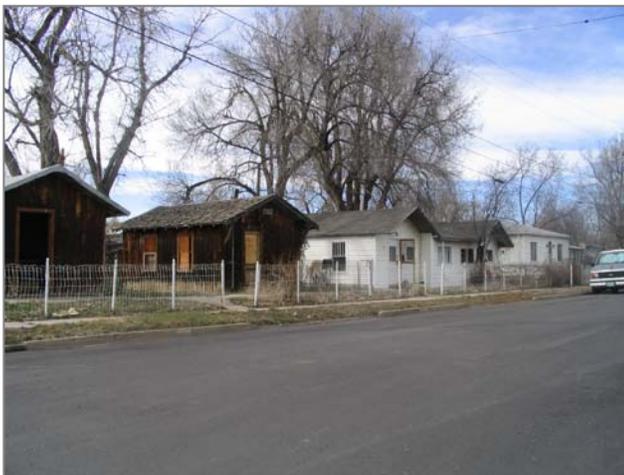
Examples of Unsafe or Unhealthy Building Conditions

Unhealthy or unsafe building conditions are said to be present on parcels with structures that appear to have obviously unsafe structures or facilities. No interior inspections were performed, so only three parcels were considered sufficiently dilapidated, based on their exterior appearance, to be counted unhealthy or unsafe due to design or construction as per the state statute.

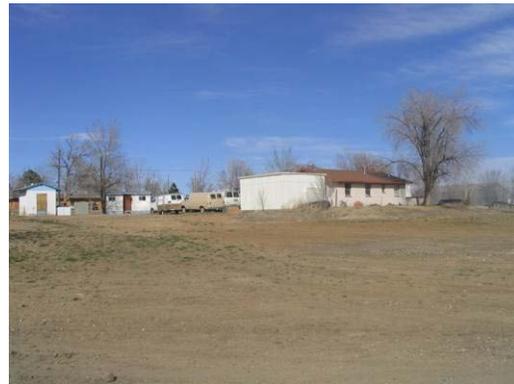
The Study Area includes 16 parcels with either vacant land or vacant buildings, amounting to 36 of the 133 total (non-road) study area acres. These properties are considered underutilized for the purposes of this analysis.
