Historic Preservation Commission Agenda

**Monday, April 15, 2024
City Hall, Spruce Conference Room
749 Main Street
6:30 PM**

OWNER & APPLICANT: JoAnna Alidu
928 La Farge Avenue
Louisville, CO 80027

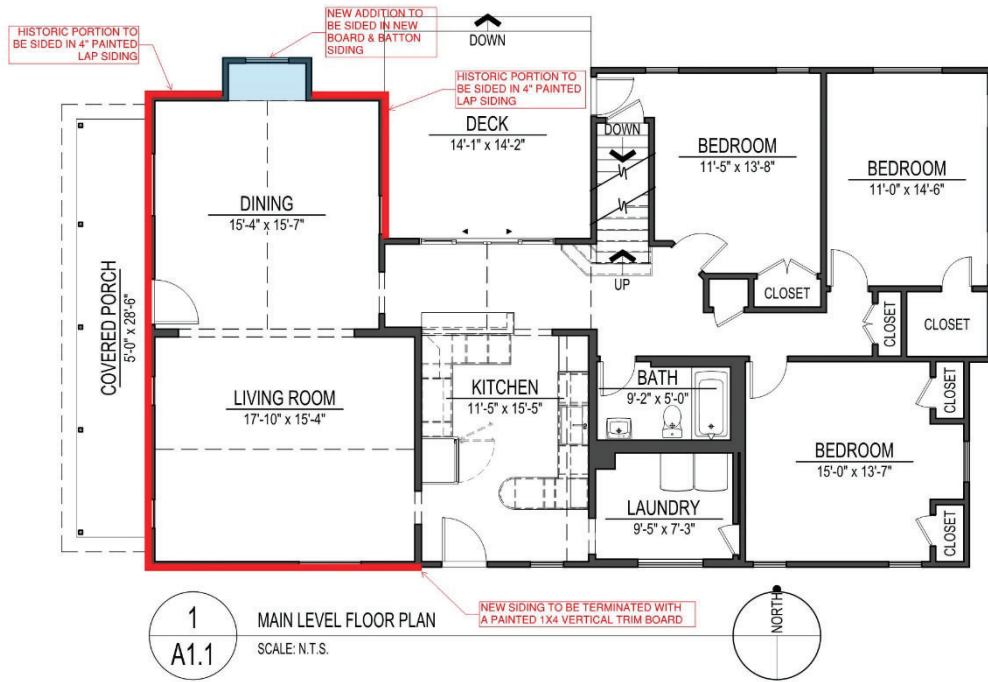
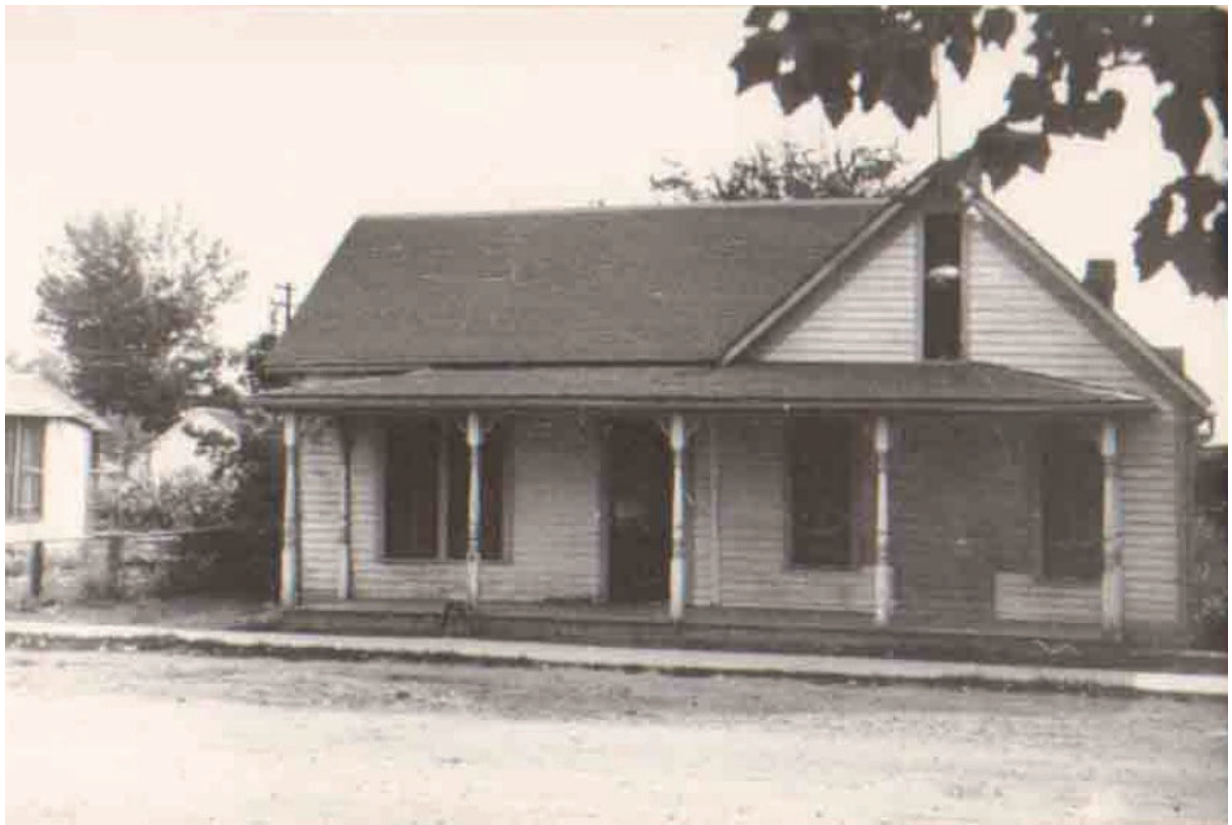
1950'S PHOTO

The 1950's photo shows the historic lap siding that has since been removed. Lap siding was the common siding for this era house and in particular for this portion of Lafarge Ave.

The owner wishes to replace the vinyl siding on the historic portion of the house and her contractor has already removed the siding from the front portion of the house. It was discovered during that process that the historic siding was removed and will need to be replaced per the historic photos from from the HSA. The replacement siding will be a painted lap siding with a 4" reveal and the trim will be a 3-1/2" painted trim surrounding the windows, doors and the corners of the historic portion of the building. See the extend of the siding replacement below.

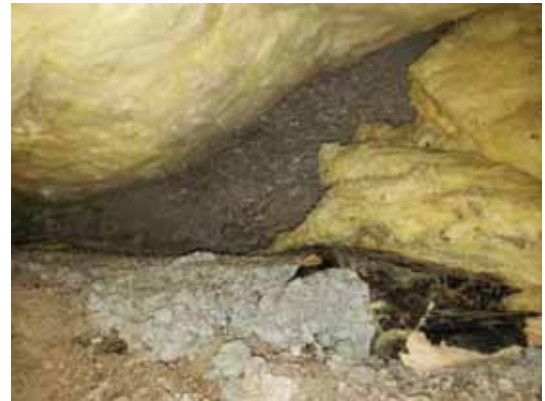
The portion of the house built prior to 1995 is built over a crawlspace less than two feet deep with a central area dug down approximately four feet or more that provides limited access. This crawlspace area is accessed on the east side from a full-depth basement below the 1995 addition. The crawlspace has a vapor barrier throughout, and the foundation walls are covered with a fiberglass insulation. The insulation was pulled away in a few locations to reveal a shallow concrete foundation with a concrete footing. It appears that this type of foundation wall encompasses the entire portion of the house built prior to 1995. It is unclear if the concrete was poured over an original foundation of either stacked stone or brick or the original foundation may have been replaced by the existing concrete. The foundation under the original house could not be determined from the exterior as siding runs to grade. Due to the insulation covering the foundation walls in this area, it is impossible to determine how the floor joists bear on the foundation and whether or not a sill plate exists.

Crawlspace foundation with insulation pulled back

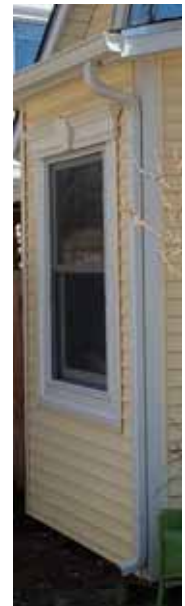
Typical gutter & downspout without an extension

1. Historical images show half-round gutters with round downspouts. The existing gutters and downspouts should be removed and replaced with this historic style.
2. The downspouts should discharge water away from the foundation. Gutter extensions should be added to all gutters or consider direct-burial downspouts where extensions cannot be located or in areas where extensions would present a tripping hazard.

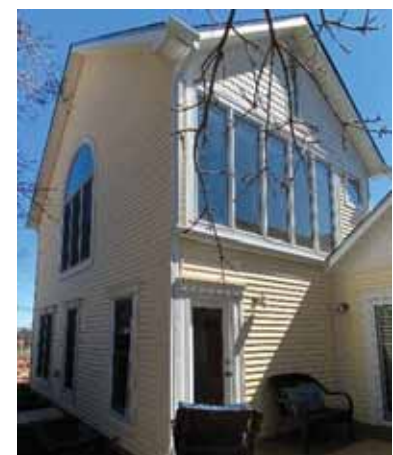
North & west side windows

Remove the north side bay window and transom window above the bay. It is possible that there may have been a window on this side of the original structure but there is no photographic evidence, and any structural evidence was likely lost with the addition of the bay. If evidence of a window is found during removal of the bay and siding, a window matching the sizes and styles of the other original windows should be added at this location.

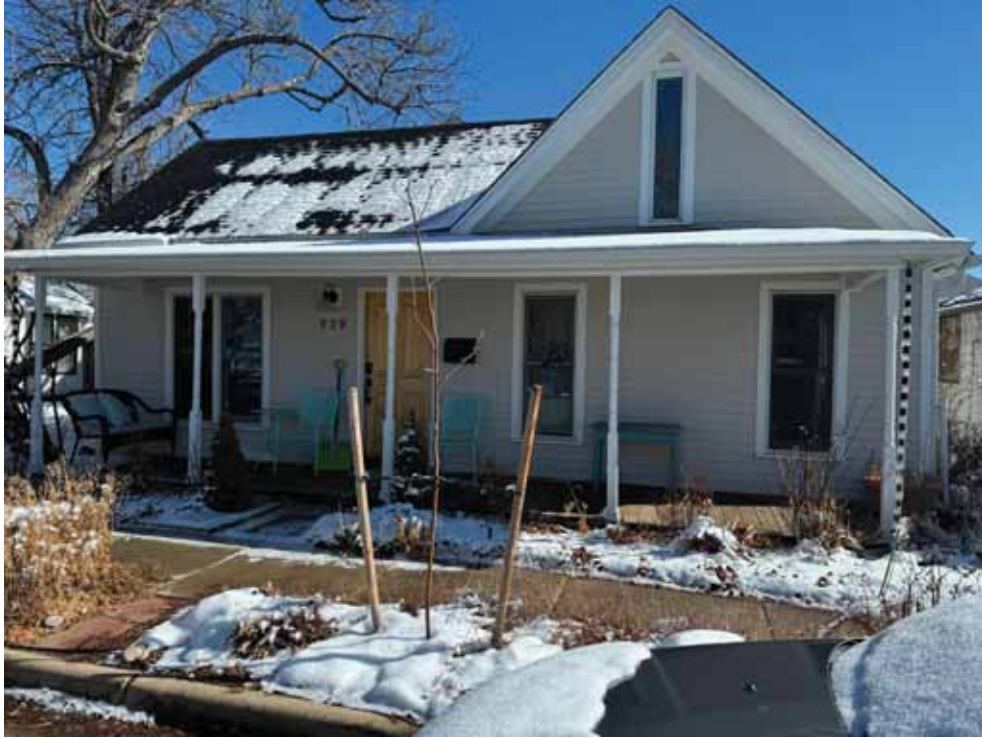
Restoration of siding on the historic part of the house, built in 1890.

This image shows the siding work that has been completed per the HSA recommendations. This is part of the grant request. The windows shown in this image are to be replaced.

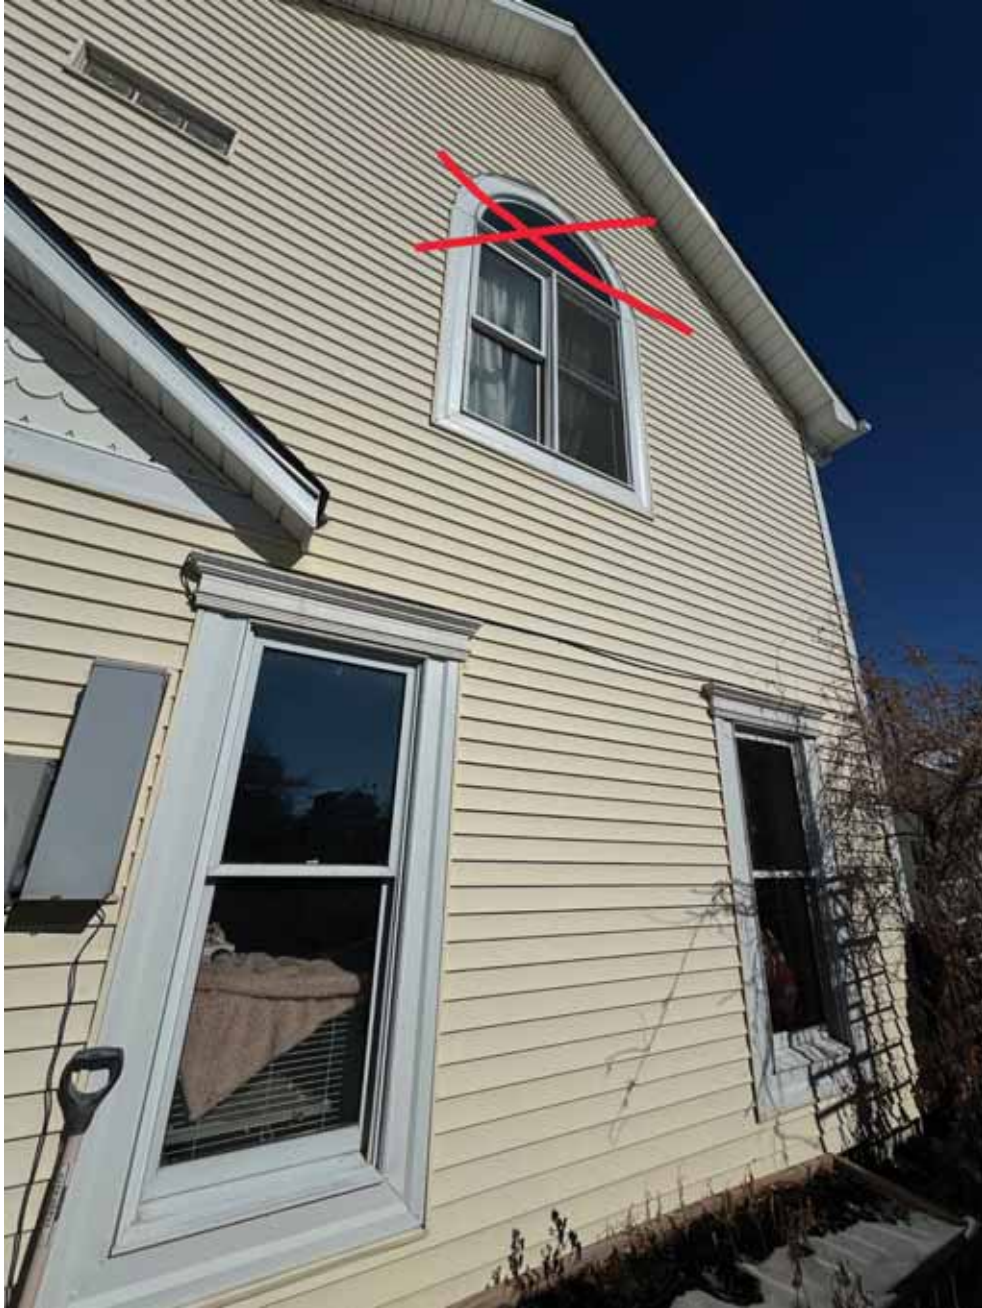
928 La Farge Avenue
South side of non-historic part of the house - not part of the grant request.
Change to existing window:
Remove half-circle window. Replace with 2 taller double hung windows.

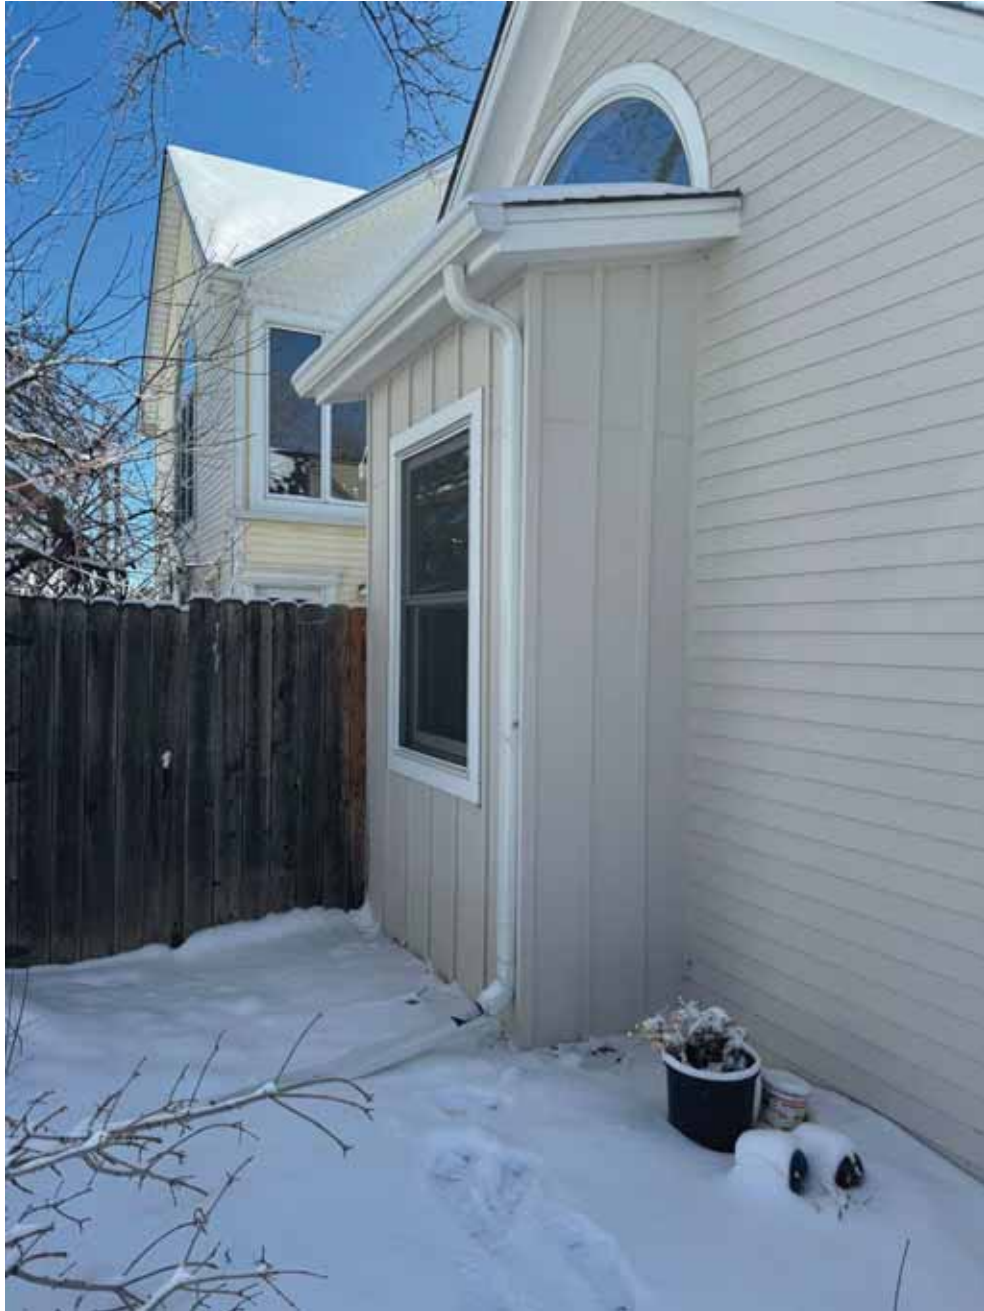
928 La Farge Avenue

half-circle window to be replaced with a transom window.

Row of windows to change to have 3 windows across, not 5.

North side with bay window. The bay window was added on to the historic part of the house with the half-circular window above. It was decided with DAJ Design to side this section with board and batten siding to distinguish it from the historic part of the house.

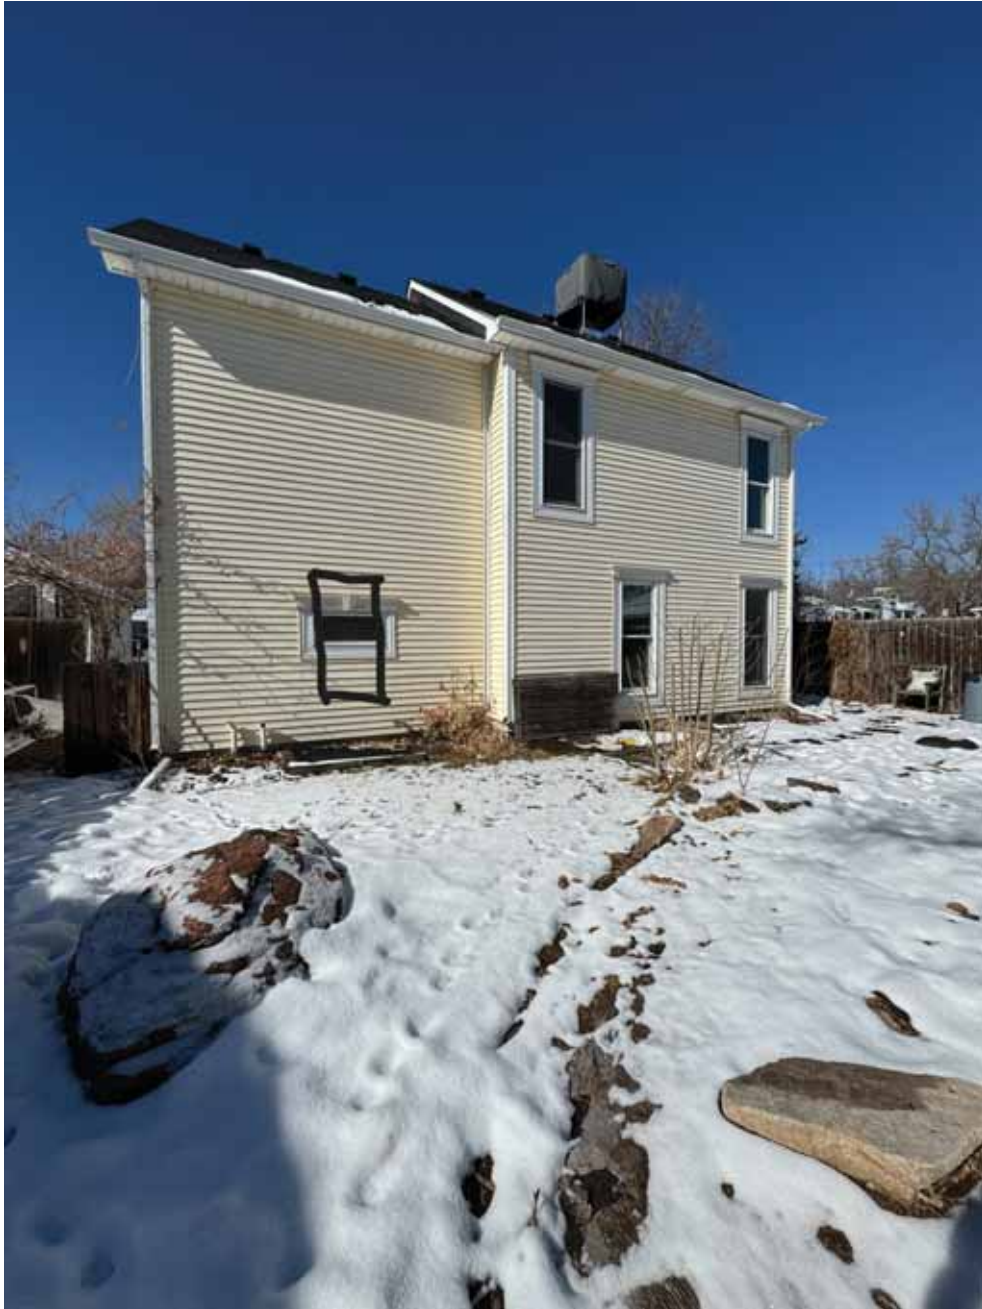
928 La Farge Avenue

East side of non-historic part of the house - not part of the grant request.

Remove small window. Replace with taller double hung window, same size as other windows in the photo that are on the first floor.
