COLORADO CULTURAL RESOURCE SURVEY

Architectural Inventory Form

- 1. Resource number: **5BL8005**
- 2. Temporary number: **N/A**
- 3. County: **Boulder**
- 4. City: **Louisville**
- 5. Historic building name: **Burns House; Willis House**
- 6. Current building name: **Mary's Beauty Boutique**
- 7. Building address: **600 Main Street**
- 8. Owner name: **Mary Stead & Anne Spendlow**
Owner address: **600 Main Street**
Louisville, CO 80027

48. Report title: **"Old Town" Louisville Historical Building Survey**

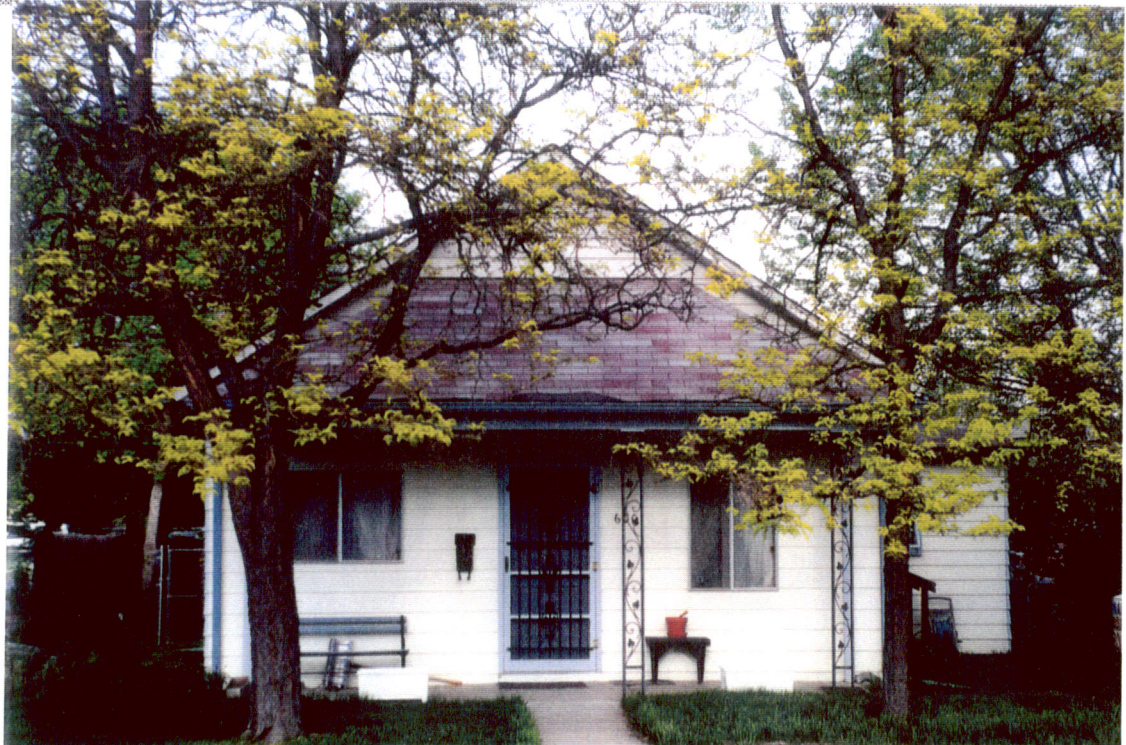
This house, presently used both as a beauty parlor, and as a residence, is a rectangular-shaped wood frame dwelling, supported by a low concrete foundation. The building's exterior walls are comprised of painted pale yellow wide horizontal wood siding, and the roof is a moderately-pitched front gable, with red asphalt shingles and boxed eaves. There are no chimneys. Windows include original 1/1 double-hung sash, with painted blue wood frames, and several non-original 1x1 horizontal sliders, with metal frames. A painted blue wood-paneled door, with a painted blue wood screen door, opens onto a concrete porch, which extends nearly the full length of the facade (west elevation). Black wrought iron posts hold up a hipped porch roof. A wood-paneled door, with a white metal storm door, opens onto a redwood deck, located on the east elevation. The deck is covered by a shed roof, and is approached by a handicapped ramp. A third entrance is located on the south elevation, where a painted blue wood-paneled door, with a black wrought iron security door, opens onto a 4-step wood porch.

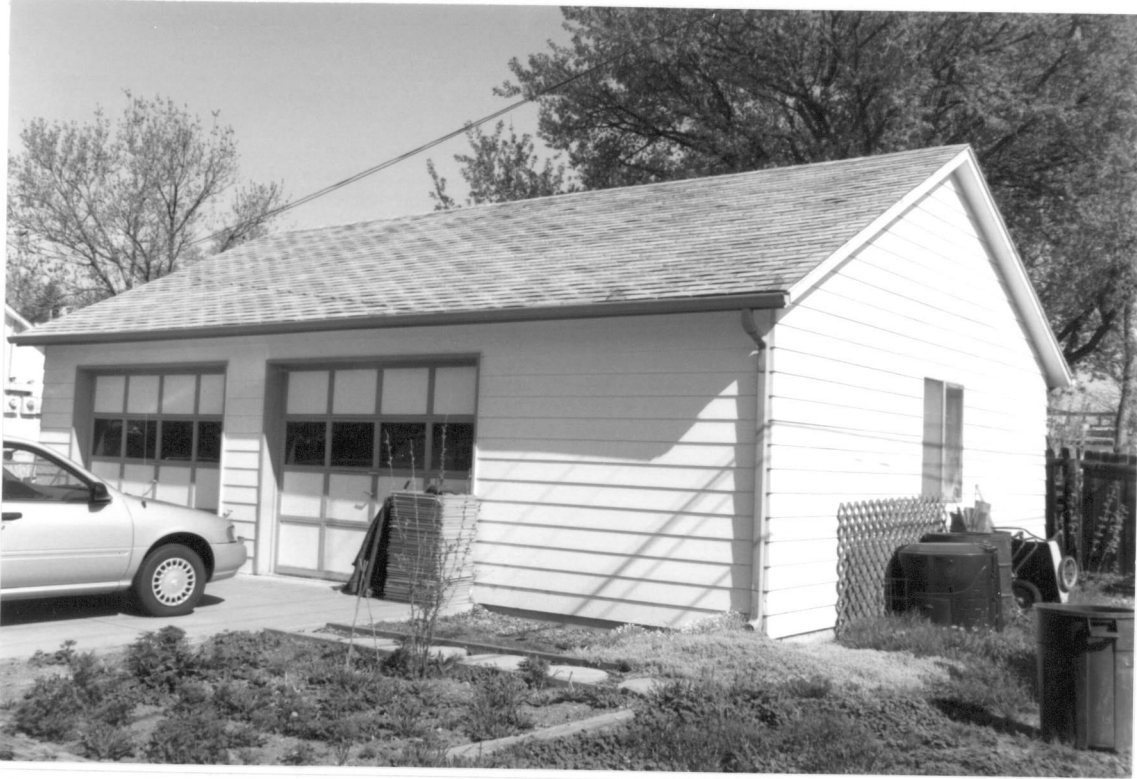
600 Main Street

5BL8005 600 Main Street, Louisville
House / Beauty Salon
27 April 2000
Negative located at: City of Louisville
749 Main Street, Louisville, CO 80027
Photographed by Carl McWilliams
Roll CM-12 Frame 10
View to SE
