# COLORADO CULTURAL RESOURCE SURVEY

## Architectural Inventory Form

- 1. Resource number: **5BL8007**
- 2. Temporary number: **N/A**
- 3. County: **Boulder**
- 4. City: **Louisville**
- 5. Historic building name: **Lakovich House**
- 6. Current building name: **All State Insurance Office**
- 7. Building address: **609 Main Street**
- 8. Owner name: **Jane A. & Gary R. Salisbury**  
Owner address: **609 Main Street**  
**Louisville, CO 80027**

48. Report title: **"Old Town" Louisville Historical Building Survey**

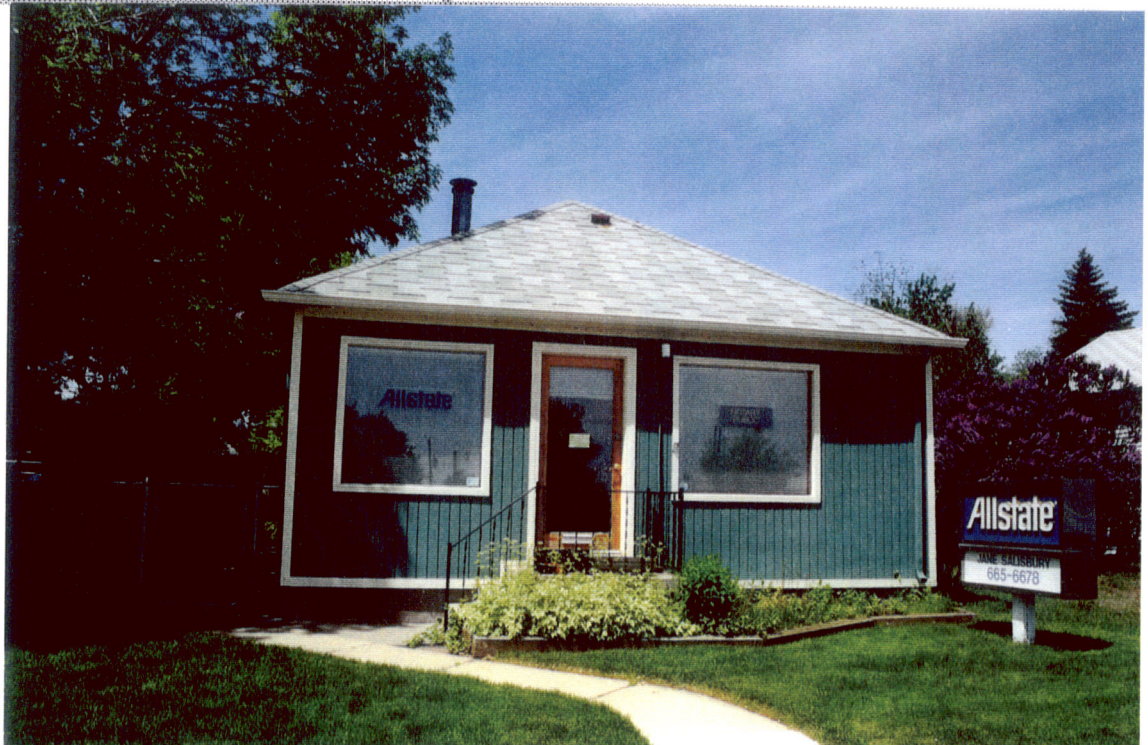
**Hipped-Roof Box**

The All State Insurance Office building is a one-story, wood-frame, rectangular structure. Although it is now an office building, for most of its history, the building served as a residence. The building is supported by a low concrete foundation, and the exterior walls are non-historic, painted blue-green vertical wood siding. The roof is hipped, with green asphalt shingles and boxed eaves. A crumbling red brick chimney is located at the west end of the north elevation. Windows are entirely non-original, and include single-light fixed-panes, and 1x1 horizontal sliders. A non-original glass-in-wood-frame entry door on the facade (east elevation) opens onto a 3-step concrete porch, with a black wrought iron. The porch is also not historic. A wood-paneled door, with an aluminum storm door, opens onto a concrete porch and sidewalk on the west elevation.

A small one-room **Miner's Cabin** is located at the north end of the west elevation. This is a 6' by 8' wood frame building, covered by a gable roof with grey asphalt shingles. The exterior walls are square-cut wood shingles.
