COLORADO CULTURAL RESOURCE SURVEY

Architectural Inventory Form

Stolns House

616 Front Street

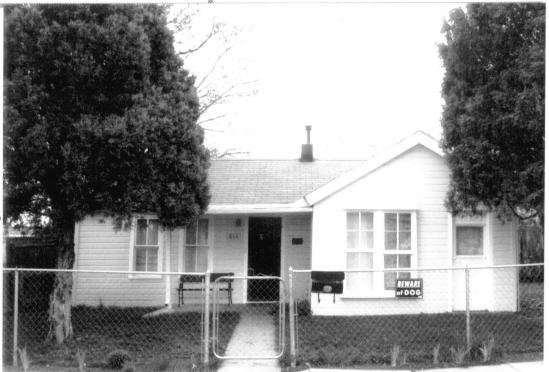
The house at 616 Front Street is supported by a low concrete foundation, and features painted yellow horizontal weatherboard walls, with 1" by 4" cornerboards. The cross gabled roof is covered with brown asphalt shingles, and has painted white boxed eaves. A brick chimney is located on the ridge. Window patterns include 2/2 double hung sash, 4/4 double hung sash, and 2-light hoppers, all with painted white wood frames and surrounds. Located on the west elevation, the house's primary entry features a painted white wood-paneled door with two upper sash lights with rounded tops. This door, accompanied by a painted black wood screen door, opens onto a concrete shed-roofed porch, with a painted yellow 4" by 4" wood post. Another wood-paneled door. located at the south end of the facade, features carved sunburst motifs in its panels, egg-and-dart molding, and a single light in its upper sash. An 18' by 6' shed-roofed extension to the east (rear) elevation features 1x1 horizontal sliding windows. A painted white wood-paneled door, with a glass-in-steel frame storm door, opens from the addition onto a concrete, shed-roofed porch, on the east elevation.
