COLORADO CULTURAL RESOURCE SURVEY

Architectural Inventory Form

Jasko House

624 LaFarge Avenue

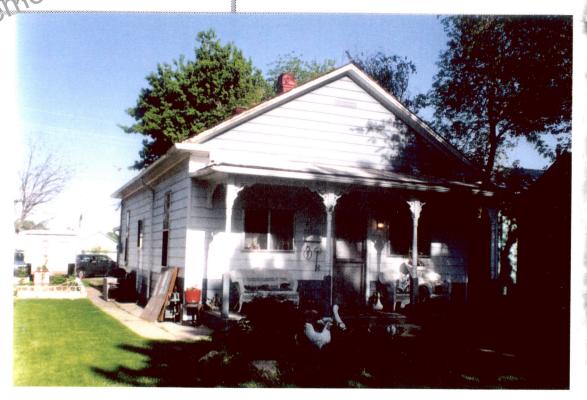
This one-story dwelling is supported by a low concrete foundation, and features white and grey horizontal aluminum siding over wood frame construction. The roof is a moderately-pitched front gable, with grey asphalt shingles and boxed eaves. Two red brick chimneys, with corbelled caps, are located on the ridge. Original windows are entirely 2/2 double-hung sash with painted white wood frames and surrounds, and with exterior metal storm windows. Non-original windows include two lxl horizontal sliding windows on the west elevation, a 1x1 horizontal sliding bathroom window on the north elevation, and two 4light hoppers on the south elevation. A wood porch, covered by a low-pitched hipped roof, extends the full length of the house's west elevation (facade). The porch roof is held up by four, painted grey and white, turned columns, with decorative brackets. A painted white wood-paneled door, with a metal storm door, opens onto the porch. A shed-roofed addition, and an enclosed rear porch addition to the east (rear) elevation, predate 1950. A solid wood door, with a metal storm door, enters the enclosed rear porch at the east end of the north elevation.
