COLORADO CULTURAL RESOURCE SURVEY

Architectural Inventory Form

II. GEOGRAPHIC INFORMATION

22. Architectural style / building type:

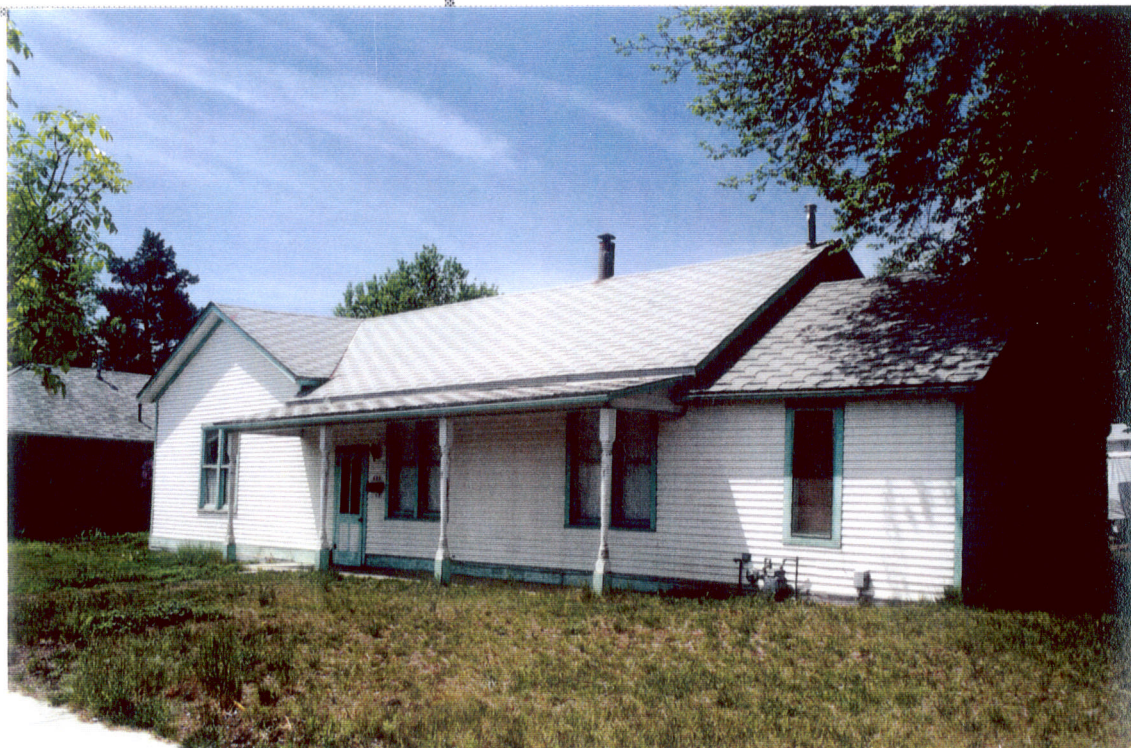
The Moffitt House is a roughly rectangular-shaped, one-story, wood-frame dwelling. The building is set well back from the curb on a lot on the west side of Main Street, at the south end of downtown Louisville. The building is supported by a concrete foundation (possibly with stone underneath), and the exterior walls are clad with non-original white vinyl siding. The intersecting gables roof is covered with asphalt shingles, and has boxed eaves. There are no chimneys. A concrete porch, covered by a shed roof, held up by painted white turned columns, covers the middle three bays on the facade (east elevation). A painted green wood-paneled door, with two slender upper sash lights with rounded tops, and with a distinctive wood screen door, opens onto the porch at its south end. A secondary entrance is located on the building's west (rear) elevation. At this location, a painted white wood-paneled door, with a painted green wood screen door, opens onto a concrete porch, covered by a shed roof. The house's windows are single and paired 1/1 and 2/2 double-hung sash, with painted green wood frames and surrounds.

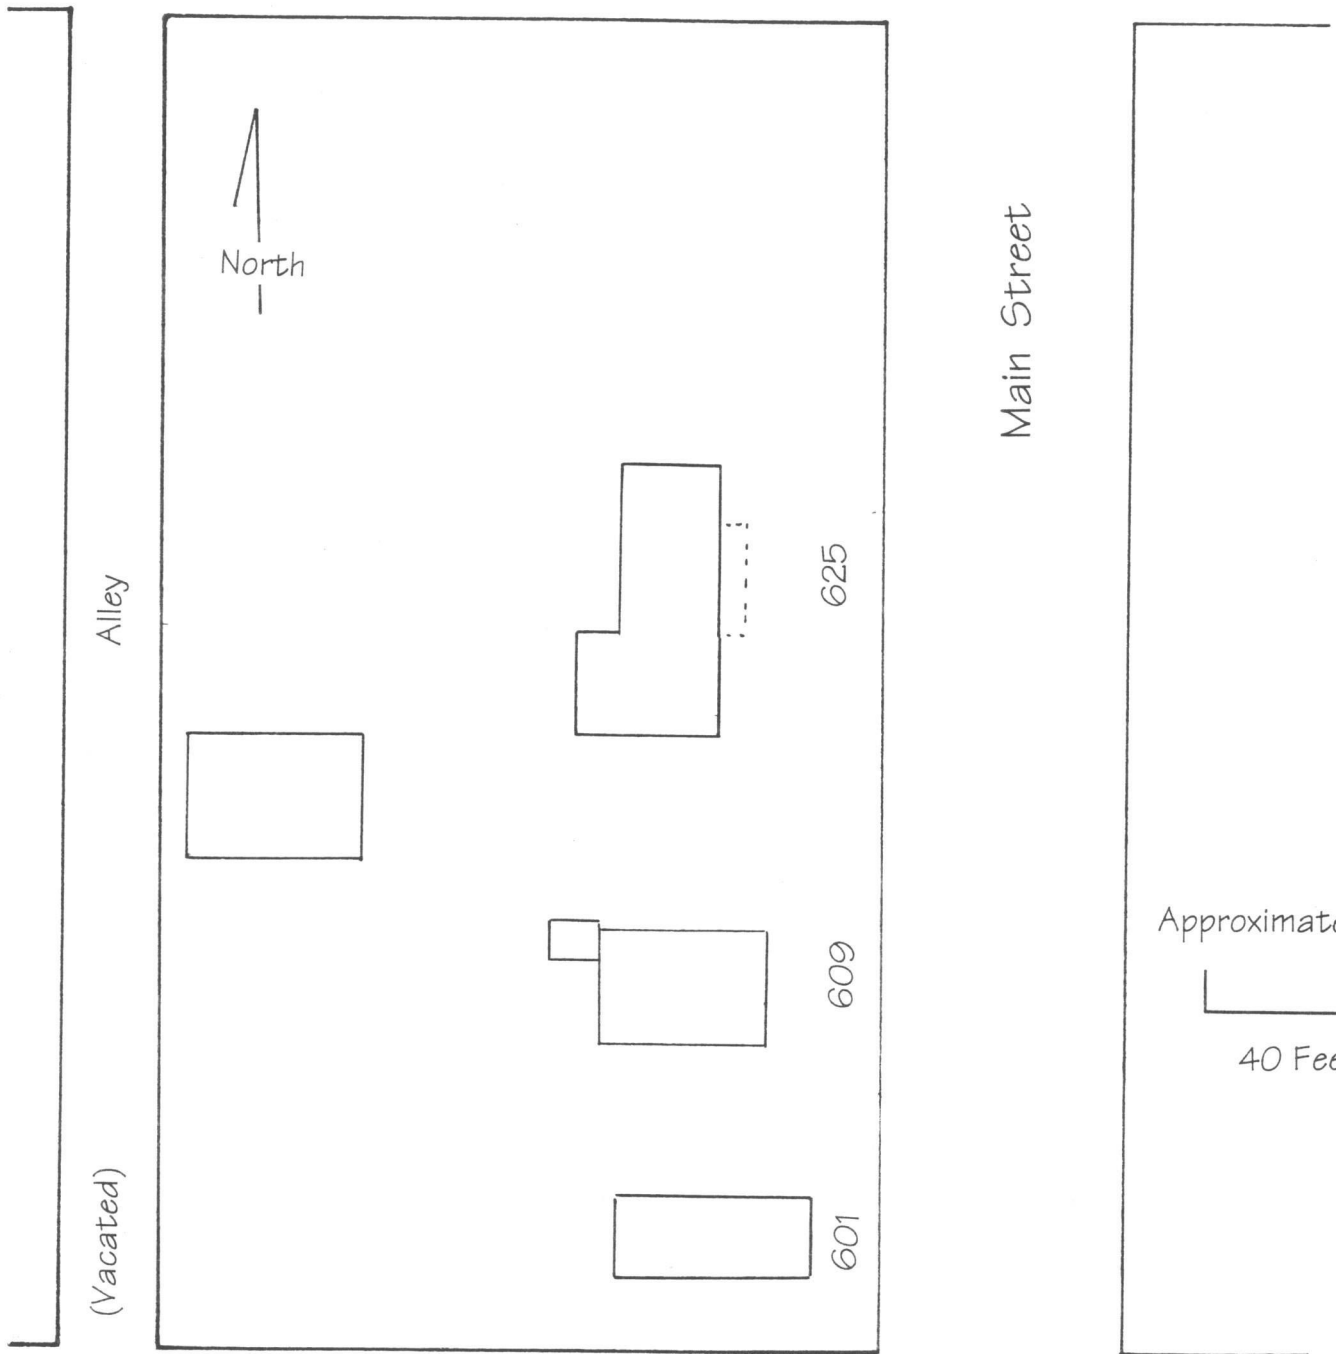
SKETCH MAP

625 Main Street, Louisville, Colorado
