# COLORADO CULTURAL RESOURCE SURVEY

## Architectural Inventory Form

- 1. Resource number: **5BL7966**
- 2. Temporary number: **N/A**
- 3. County: **Boulder**
- 4. City: **Louisville**
- 5. Historic building name: **Morgan House et. al.**
- 6. Current building name: **La Hacienda Furniture**
- 7. Building address: **630 Front Street**
- 8. Owner name: **James R. & Judy Christine Garcia**  
Owner address: **324 Morning Star Lane**  
**Lafayette, CO 80026**

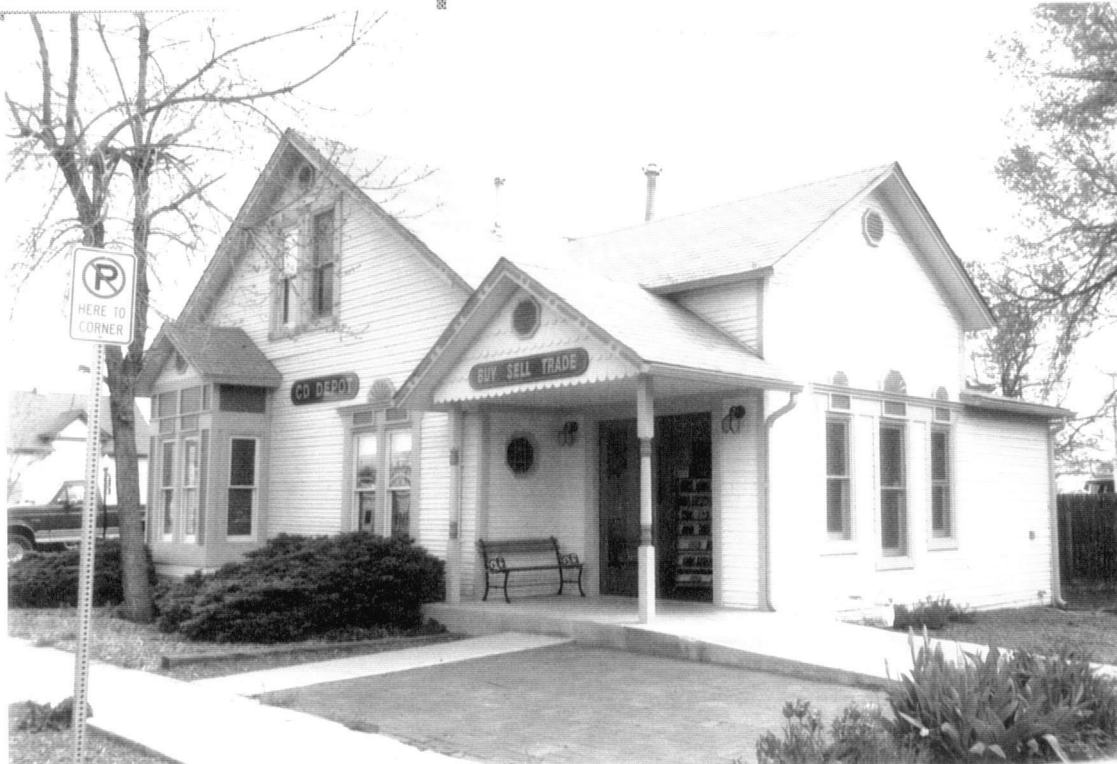
Resting on a low concrete foundation, this building features painted pale yellow horizontal wood siding, with painted pale green 1" by 4" corner boards. The north elevation, however, has been stuccoed. The building is covered by an intersecting gables roof, with green asphalt shingles, and boxed eaves. On the facade (west elevation), the eaves feature alternating dark green and pale green decorative elements. There is no chimney. Original windows are primarily 1/1 double-hung sash, with painted pale green wood frames and surrounds, and some are topped by non-original sunburst motifs. A gable-roofed rectangular bay window on the facade features one set of paired 1/1 double-hung sash windows, and two single 1/1 double-hung sash windows. Windows on the building's east elevation, including one small 1x1 horizontal slider, and three single-light fixed-panes, are not historic. The building's primary entrance is located at the south end of the facade. Here, a glass-in-wood-frame atrium door opens onto a 10' by 9' concrete porch, covered by a gabled porch roof with turned column supports. The gable end of the porch roof features fishscale shingles. An 8' by 6' hipped roof addition to the building's southeast corner predates 1950.

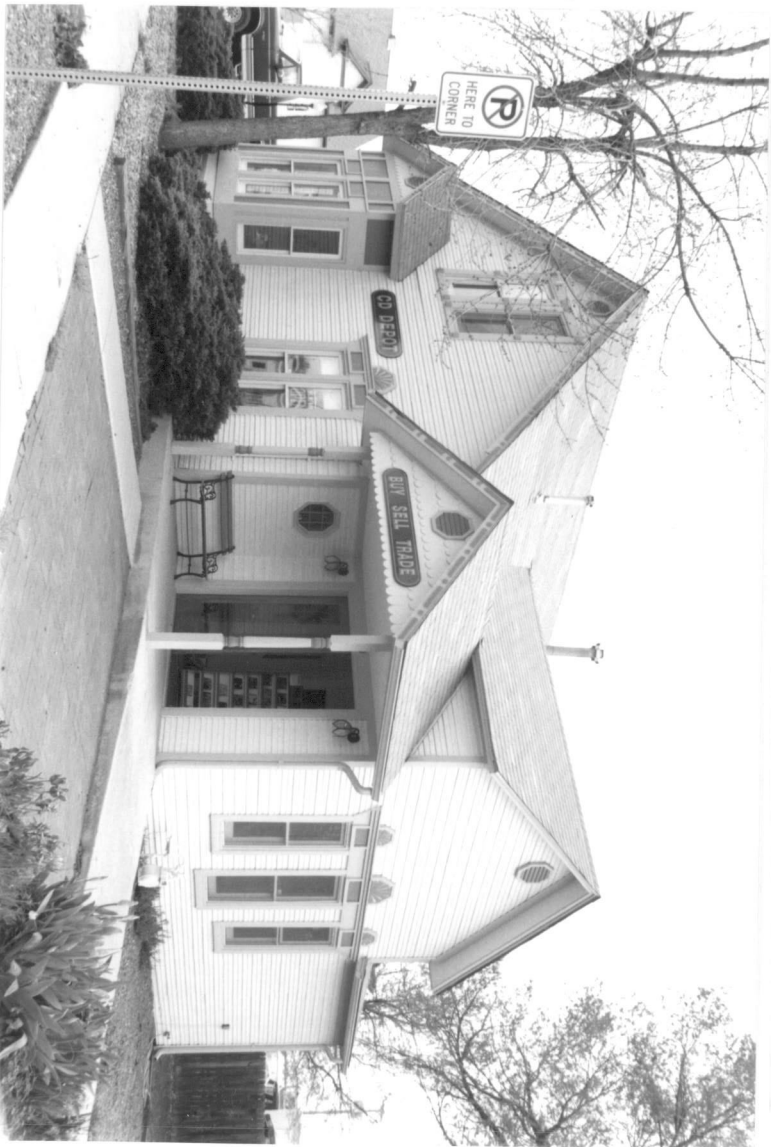
5BL7966                      630 Front Street, Louisville  
CD Depot Building  
26 April 2000  
Negative located at: City of Louisville  
749 Main Street, Louisville, CO 80027  
Photographed by Carl McWilliams  
Roll CM-7                      Frame 2  
View to NE

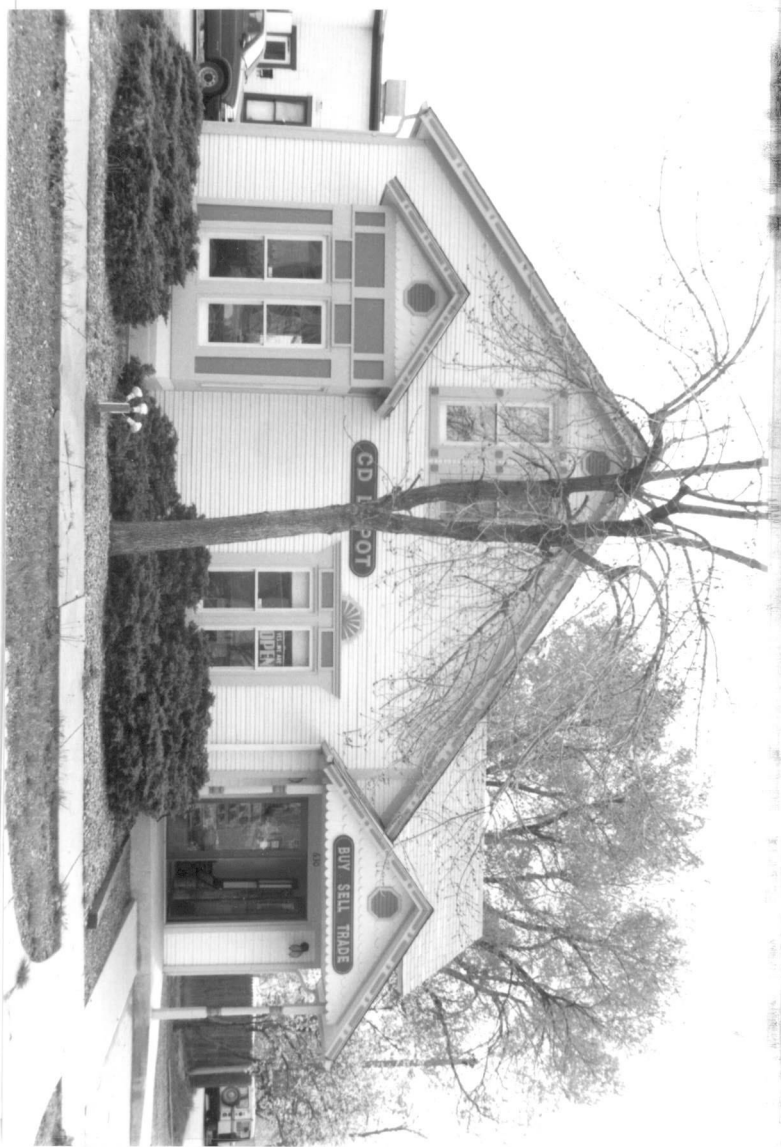
5BL7966                      630 Front Street, Louisville  
CD Depot Building  
26 April 2000  
Negative located at: City of Louisville  
749 Main Street, Louisville, CO 80027  
Photographed by Carl McWilliams  
Roll CM-7                      Frame 3  
View to SW
