COLORADO CULTURAL RESOURCE SURVEY

Architectural Inventory Form

1. Resource number: **5BL8024**
2. Temporary number: **N/A**
3. County: **Boulder**
4. City: **Louisville**
5. Historic building name: **Sirokman House**
6. Current building name: **Escobedo House**
7. Building address: **809 Pine Street**
8. Owner name: **Albert & Rita Escobedo**
Owner address: **809 Pine Street**
Louisville, CO 80027

48. Report title: **"Old Town" Louisville Historical Building Survey**

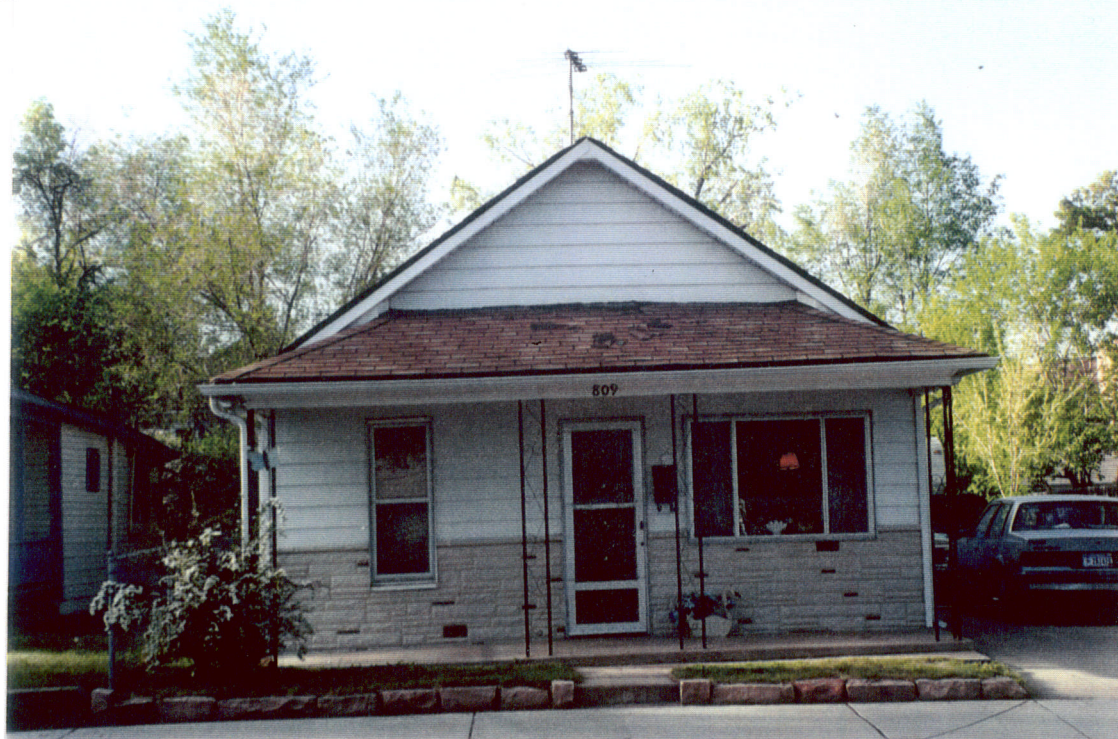
The Escobedo House is situated on a narrow lot, on the north side of Pine Street just to the west of downtown Louisville. The house is a single-story, wood-frame, dwelling, with a front gabled rectangular plan. The building is supported by a low concrete foundation, and the exterior walls are clad with white horizontal aluminum siding. The roof is a moderately-pitched front gable, with grey asphalt shingles and boxed eaves. Window patterns include historic 1/1 double-hung sash, as well as non-historic single-light fixed-panes, single-light casements, single-light hoppers. The house's facade, located on the south elevation, is set back minimally from the sidewalk along Pine Street, and is symmetrically A stained natural brown solid wood door, with an aluminum storm door, opens onto a concrete porch, which extends the full length of the facade. The porch is covered by a low-pitched hipped porch roof, held up by black wrought iron posts. A secondary entrance is located at the north end of the east elevation.

This property exhibits below average integrity. Several windows have been altered, including one on the facade; the front porch is not historic, having replaced an earlier wooden porch; the exterior walls have been cladded with aluminum; and two additions were built onto the historic structure in 1959.
