# COLORADO CULTURAL RESOURCE SURVEY

## Architectural Inventory Form

- 1. Resource number: **5BL8043**
- 2. Temporary number: **N/A**
- 3. County: **Boulder**
- 4. City: **Louisville**
- 5. Historic building name: **Henning Mortuaries Building**
- 6. Current building name: **Main Street Mortgage Building**
- 7. Building address: **844 Main Street**
- 8. Owner name: **Bessie M. Wood**  
Owner address: **844 Main Street**  
**Louisville, CO 80027**

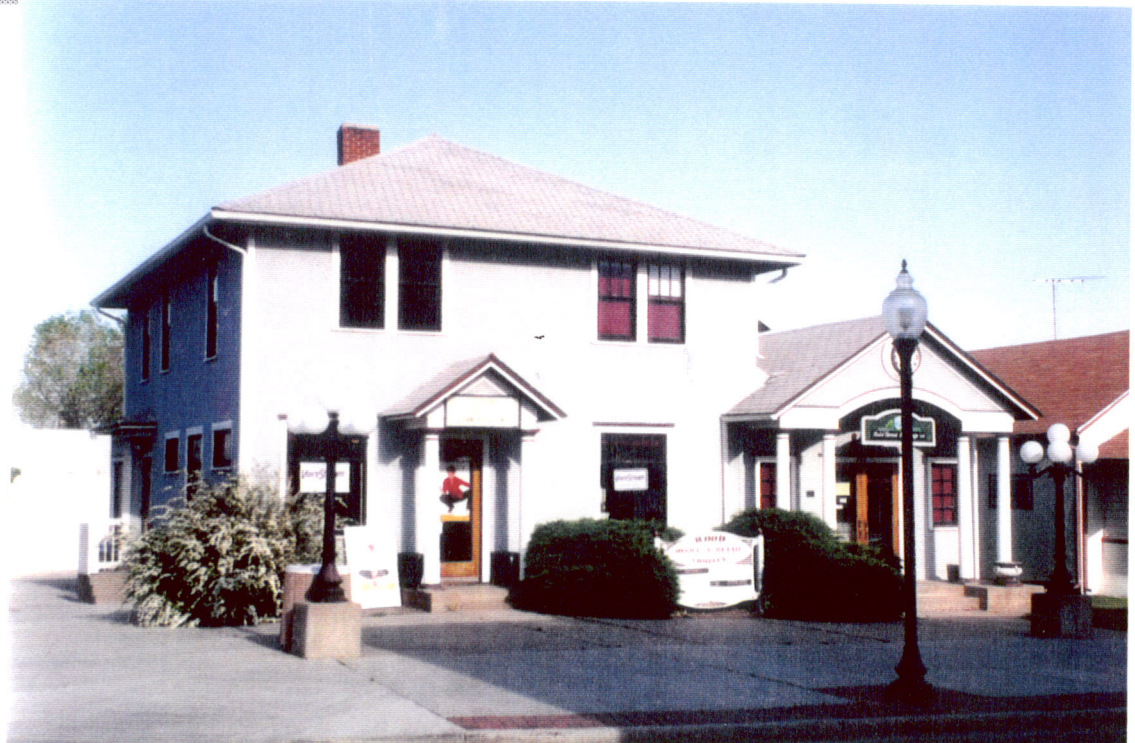
This building is comprised of two main sections - a two-story stuccoed brick masonry (or possibly wood frame) building to the north, with a square plan, and a stuccoed wood frame portion to the south, with a rectangular plan. Together, the two sections come together to create an L-shaped building.

The two-story portion has a stone foundation, with concrete pargeting, and a hipped roof, with asphalt shingles and exposed rafter ends. One red brick chimney is located on the interior of the east elevation. Window patterns on the entire building include: 6/1 double-hung sash (ribbon style), flanked by 6-light hoppers; single-light fixed-panes; 3-light fixed-panes; 3/1 double-hung sash (ribbon style); 6/1 double-hung sash (ribbon style); and 8-light fixed panes. Many of these windows are not historic, and have painted black or white wood frames and surrounds. The main entry door on the facade (west elevation), is glass-in-wood-frame, which opens onto a concrete porch, with a gabled hood supported by Doric columns. This entrance presently provides access to Cutting Edge Communications. Another glass-in-wood-frame door opens onto a small wood porch, located on the north elevation. On the east elevation, yet another glass-in-wood-frame door opens onto a handicapped ramp. (All of these doors and porches are not historic.)

The portion of the building to the south, features a front gabled plan, which is one story tall at the front (west) end, and two stories tall at the rear. A pseudo Classical Revival style facade has been put on the front end of the building, on the west elevation. Paired glass-in-wood-frame entry doors here, with flanking sidelights, provide entry into Main Street Mortgage LLC.
