COLORADO CULTURAL RESOURCE SURVEY

Architectural Inventory Form

II. GEOGRAPHIC INFORMATION

22. Architectural style / building type:

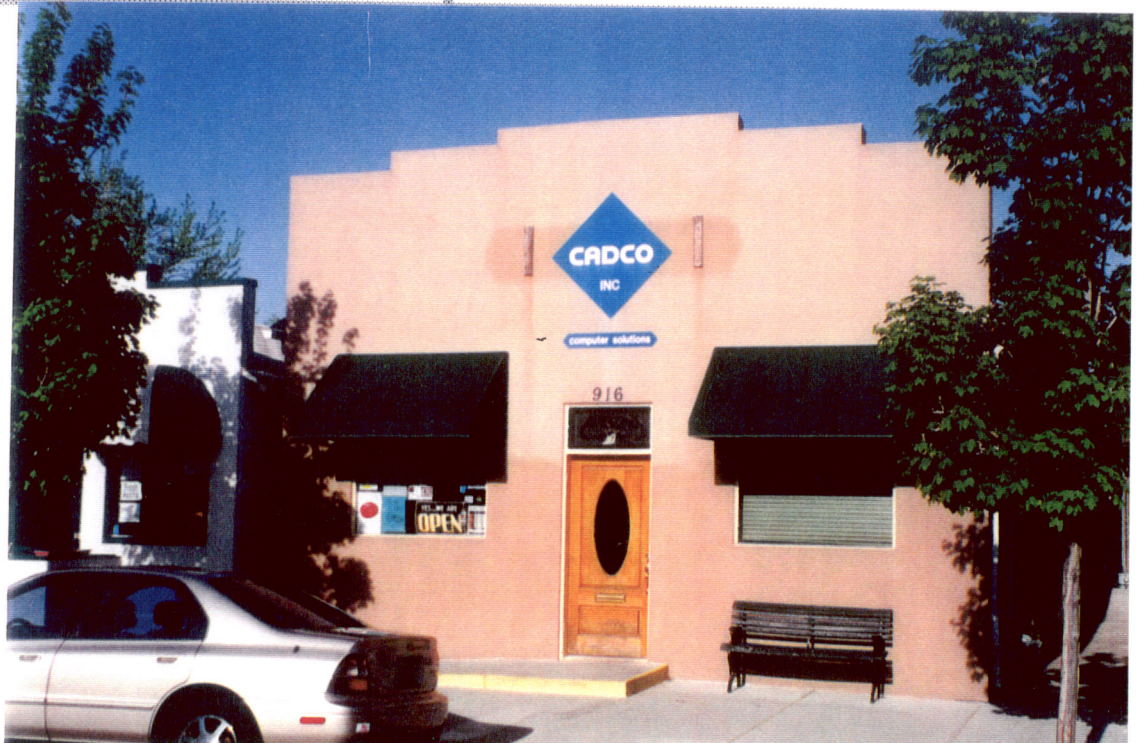
Comprised of a single commercial building, this property is located on the east side of Main Street, near the north end of downtown Louisville. The building is one-story tall, with a rectangular plan, and of wood frame construction. The facade fronts directly onto a wide concrete sidewalk which parallels Main Street, on the west elevation. The building is supported by a low concrete foundation. The facade wall is stuccoed, light brown in color, while the side walls, along the north and south elevations, are clad with wide horizontal aluminum siding. The roof is front gabled, with green asphalt shingles and boxed eaves. A red brick chimney is located on the roof ridge. The building's facade is symmetrically arranged, below a false-front parapet wall, with stepped gables. A stained natural brown solid wood door, with one oval light, and with a stained glass transom light, is located in the center of the facade. The entry door is flanked by two single-light fixed-pane storefront windows, with green canvas awnings. A large concrete block addition has been built onto the original east (rear) elevation, extending the building toward the alley. A steel roll-away garage door, opens onto a short concrete driveway on the east elevation. Four small non-original 3-light windows are located on the north elevation. Three similar windows penetrate the south elevation wall, along with one original 1/1 double-hung sash window, with a painted white wood frame and surrounds.

This building's integrity has been compromised by the construction of a large concrete block addition on the east elevation, by the application of stucco, and other alterations, to the facade, and by the application of aluminum siding along the north and south elevations.
