COLORADO CULTURAL RESOURCE SURVEY

Architectural Inventory Form

II. GEOGRAPHIC INFORMATION

22. Architectural style / building type:

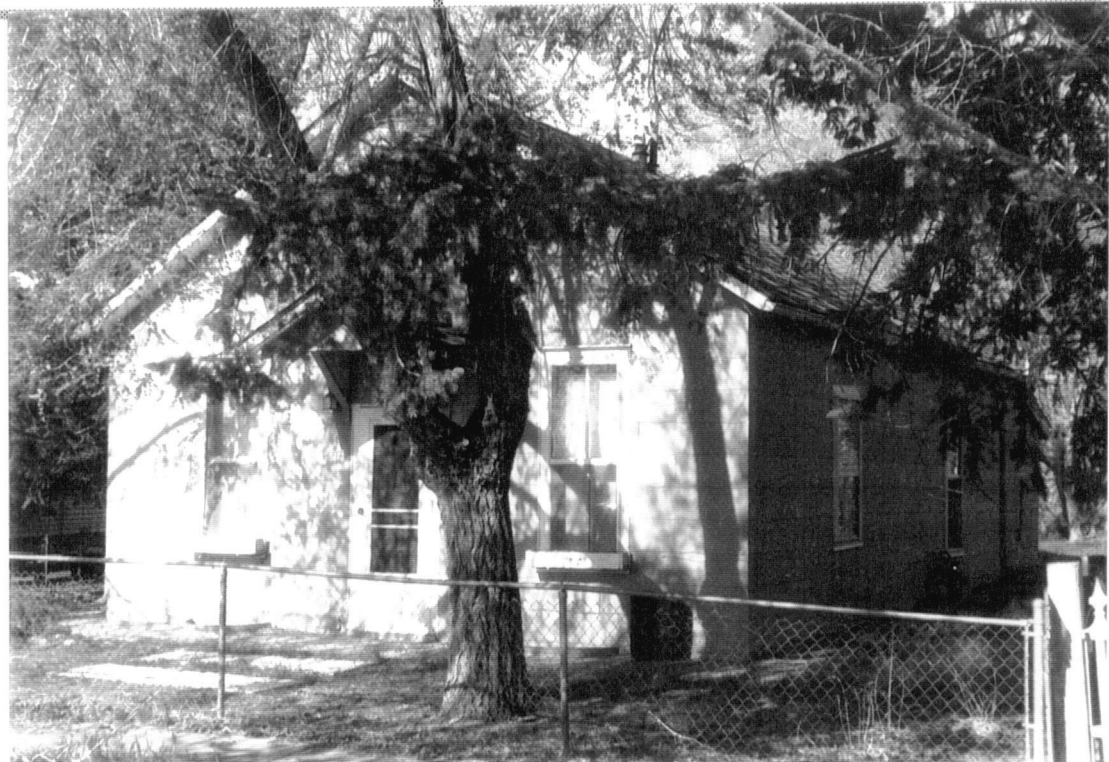
21. General Architectural Description

This wood frame dwelling is supported by a concrete foundation, and its exterior walls are comprised of blue undulated asbestos shingle siding. The front gabled roof features boxed eaves, and is covered with grey asphalt shingles. There are no chimneys. Window patterns include 1/1 double-hung sash, 2/2 double-hung sash, and 3/1 double-hung sash (ribbon style), all with painted white wood frames and surrounds, and with exterior metal storm windows. Windows on the facade (east elevation) are decorated with flower boxes beneath the sills. A stained natural brown wood-paneled door, with a painted white wood screen door, opens onto a concrete sidewalk on the facade. The entry is covered by a gabled hood with kneebrace supports. A 22' by 8' enclosed shed-roofed rear porch addition to the west (rear) elevation predates 1959. A painted white solid wood door enters the enclosed rear porch at the west end of the south elevation.
