COLORADO CULTURAL RESOURCE SURVEY

Architectural Inventory Form

II. GEOGRAPHIC INFORMATION

Official Eligibility Determination

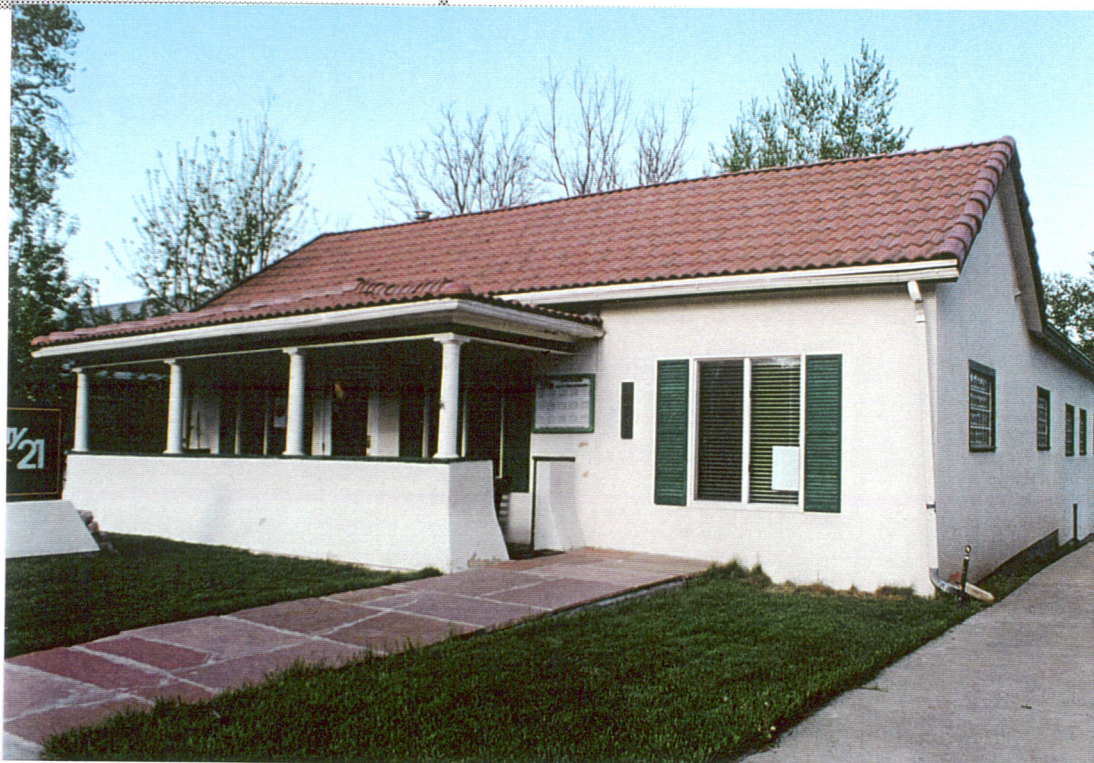
This property is comprised of a single building which historically was a residence, but has been converted into a real estate office. The building is supported by a low concrete foundation, and has light beige stuccoed exterior walls, over wood frame, or possibly brick, construction. An intersecting gables roof is covered with non-historic red clay tiles toward the front, and with asphalt shingles to the rear. A stuccoed brick chimney is located on the exterior of the north elevation. The building's windows, nearly all of which have been altered from their historic appearance, include 1x1 horizontal sliders, 2/2 double-hung sashes, and six 28-light glass block windows on the south elevation. A glass-in-wood-frame door opens onto a non-historic wood porch which covers the northern 2/3s of the facade, on the west elevation. Stuccoed wood frame half-walls, and Doric columns, support a low-pitched hipped porch roof, covered with red clay tiles. A non-historic glass-in-wood-frame door, opens onto a 3-step wood porch, with stuccoed wood frame half walls, on the east elevation. A painted white wood-paneled door, opens onto a small concrete porch, with a black wrought iron railing, on the north elevation.

This house's historical integrity was severely impacted when it was added onto and renovated, probably in 1970. The front porch has been moved from one side of the facade to the other, the red clay tile roof is not historic, nearly all of the windows have been changed from their historic appearance, and the size of the original building has been more than doubled. As a result, the building no longer conveys any sense of its historic significance.
