# COLORADO CULTURAL RESOURCE SURVEY

## Architectural Inventory Form

- 1. Resource number: **5BL908**
- 2. Temporary number: **N/A**
- 3. County: **Boulder**
- 4. City: **Louisville**
- 5. Historic building name: **Tomeo House**
- 6. Current building name: **Museum Miner's House**
- 7. Building address: **1011 Main Street**
- 8. Owner name: **City of Louisville**  
Owner address: **749 Main Street**  
**Louisville, CO 80027**

48. Report title: **"Old Town" Louisville Historical Building Survey**

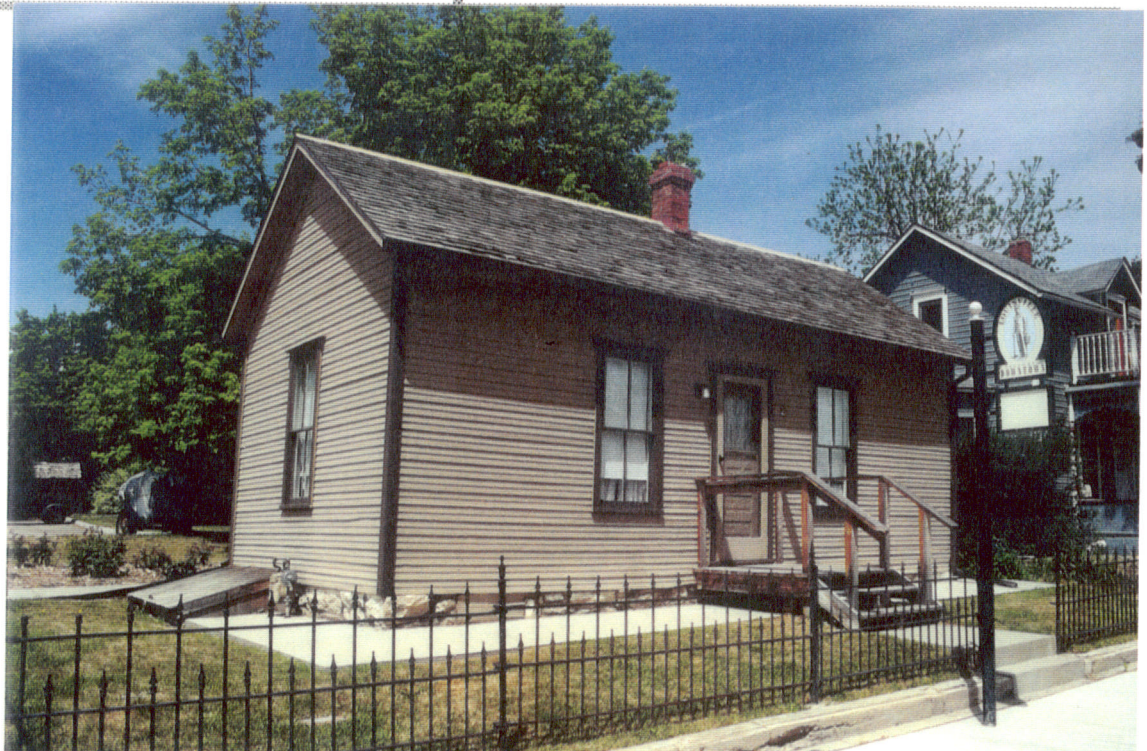
**Other Style**  
**(Wood Frame Side Gabled Dwelling)**

The Museum Miner's House is a one-story wood frame building, built with a rectangular side-gabled plan. The building measures 28' N-S by 14' E-W, with an 18' by 12' shed-roofed extension located at the north end of the west (rear) elevation. The building is supported by a low sandstone foundation, and the exterior walls are comprised of painted light brown, narrow, horizontal wood siding, with painted dark brown 1" by 4" corner boards. The side-gabled roof is moderately-pitched, and has wood shingles and boxed eaves. There are two red brick chimneys - one located on the ridge, and the other on the roof of the shed-roofed extension. The building's windows are entirely single 2/2 double-hung sash, with painted brown wood frames and surrounds, and with wood cornices. The facade is located on the east elevation, and is symmetrically arranged. A painted light brown wood-paneled entry door has one upper sash light, and features projecting carved rails, and carved panels. This wood-paneled door is protected by a glass-in-wood-frame storm door, and opens onto a 2-step wood porch. A secondary entrance is located near the west end of the south elevation. The entry here consists of a painted light brown wood-paneled door, with two narrow upper sash lights, which opens onto a wood porch.

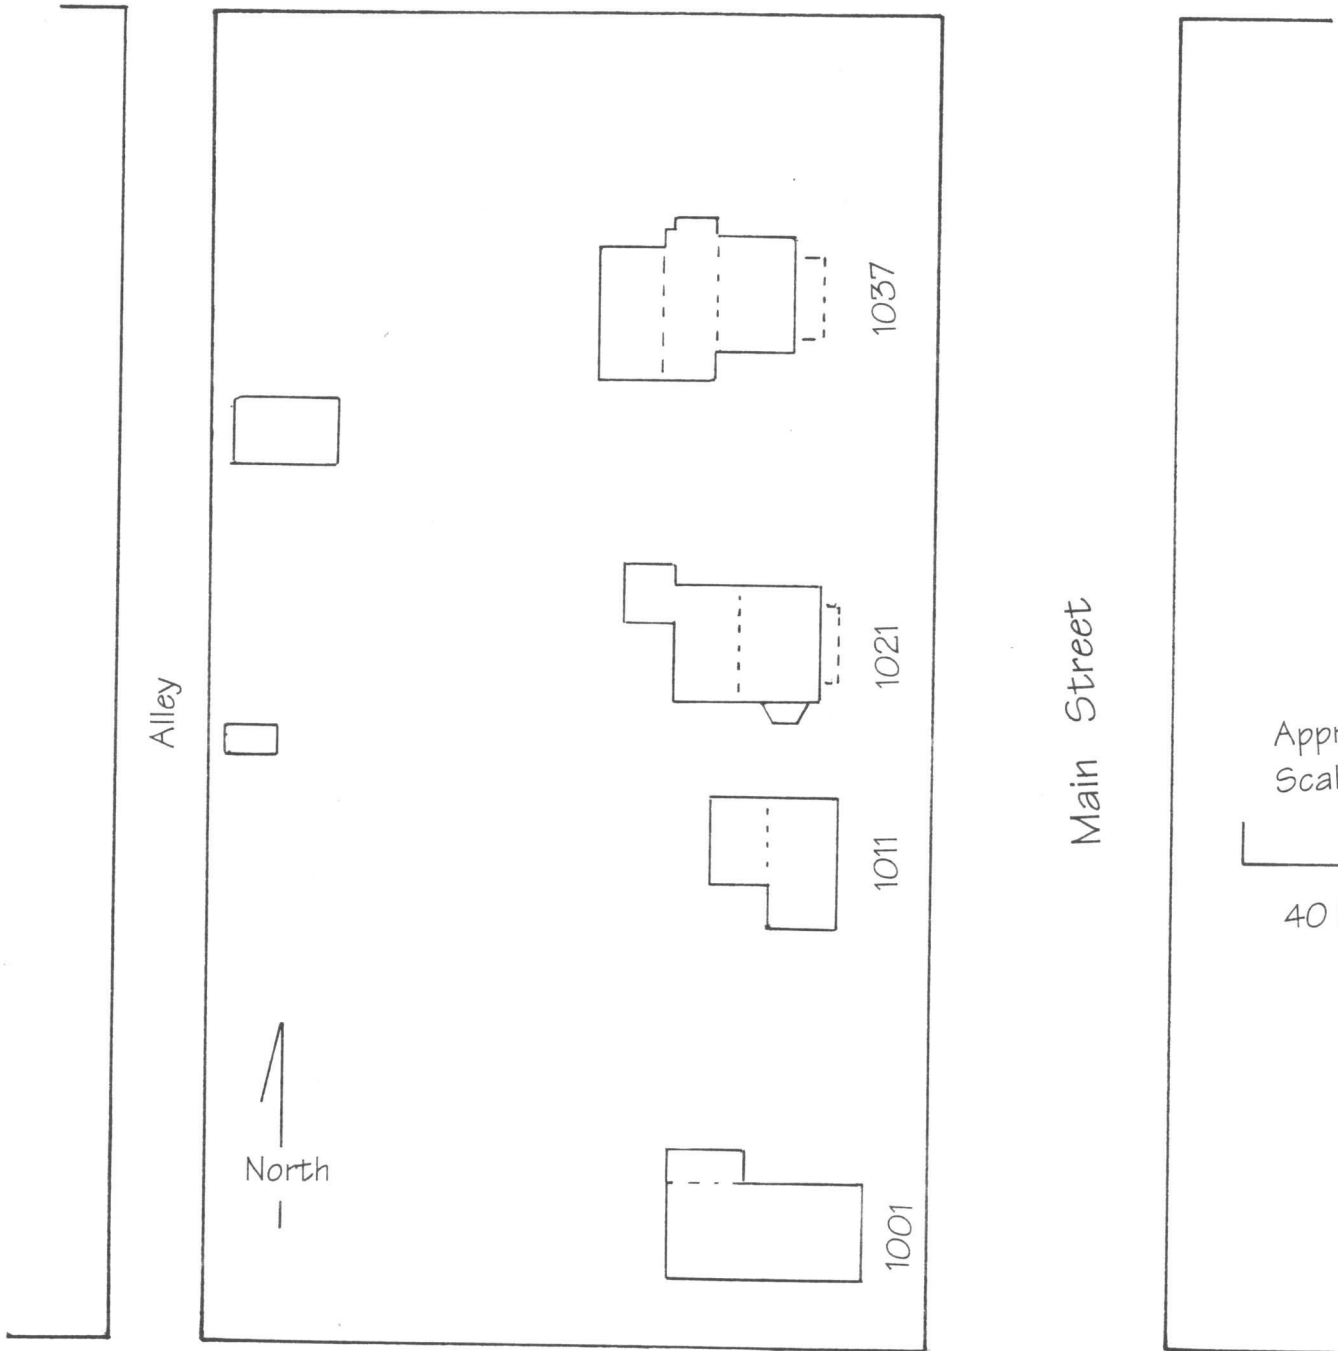
SKETCH

1011 Main Street, Louisville, Colorado
