# 550 South McCaslin Boulevard Conditions Survey

**July 2014**  
**City of Louisville, Colorado**

Urban Revitalization Consulting

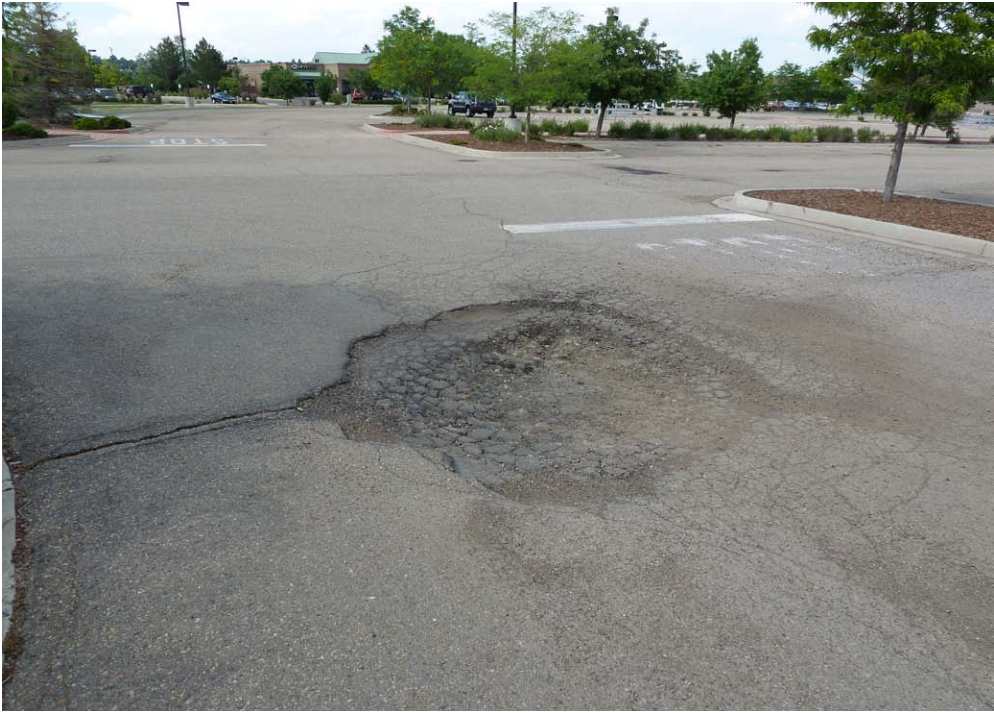
A lack of full maintenance of the property was evident during the field survey; the parking lot had a few potholes, including one very large one at its primary entrance with McCaslin Boulevard, and the curb and gutter in some places was cracked and deteriorated. The striping on the parking lot was found to be badly worn. The building itself was cracked in a few places in its facade, and needs minor work such as mortar repair in certain areas.

*The parking had cracks and potholes in places*

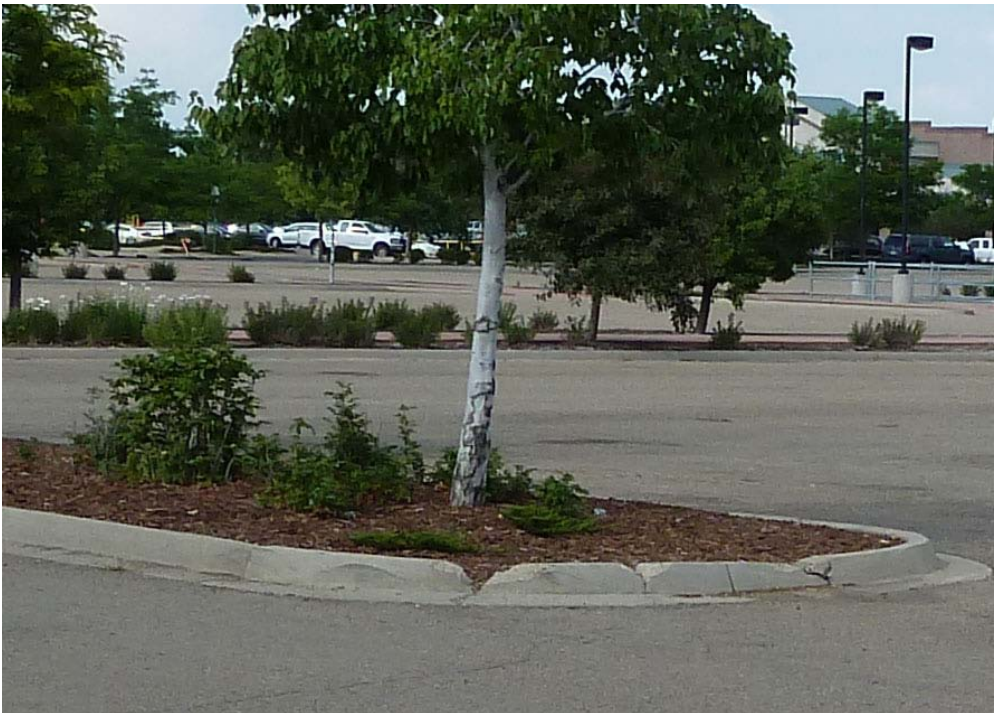
*Various portions of damaged curb and gutter were found*

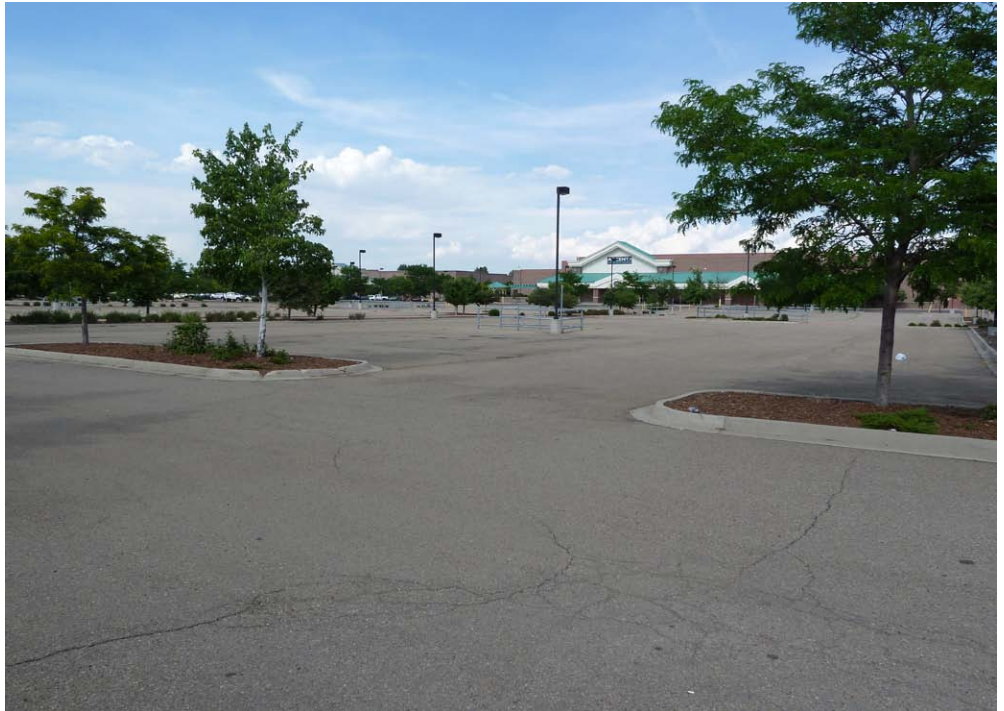
The Survey Area is 13 acres, located in an urbanized area, surrounded by commercial and residential development, on a busy arterial street near a highway interchange, but is currently vastly underutilized.

This represents a substantial underutilization of the property, which contributes to a general blight in the area and a reduction in retail traffic for the surrounding area that an anchor tenant of the sort the property was designed for would provide.

*The vast parking area and the building lie largely vacant*
