Historic Preservation Commission

ITEM: 917 Rex Street Landmark, Alteration Certificate, Grant, & Loan request

HISTORIC STRUCTURAL ASSESSMENT
917 REX STREET, LOUISVILLE, COLORADO

July 27, 2023

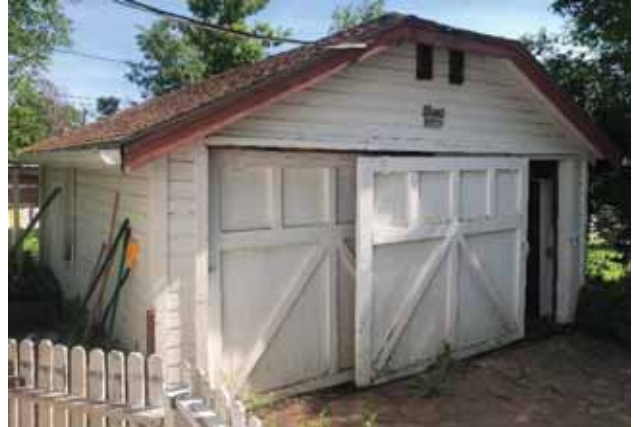
A detached, two-car garage faces south towards the street and is set back towards the rear of the house. A garage is listed on the 1948 Boulder County Assessor's card that is likely the garage that exists in 2023. Based on the historic detailing, the garage was probably built at or near the same time as the main house. The garage is wood framed, likely with 2x4 lumber. The roof rafters are 2x4 lumber with a clipped gable and exposed rafter tails on the west and east ends. The garage has the original Dutch cove siding and original sliding doors. There are a window and door on the west side and two windows on the north side.

An asphalt driveway on the east of the lot can accommodate approximately three cars. The asphalt is significantly cracked and heaving throughout. The garage and driveway yield approximately five parking spaces on the site.

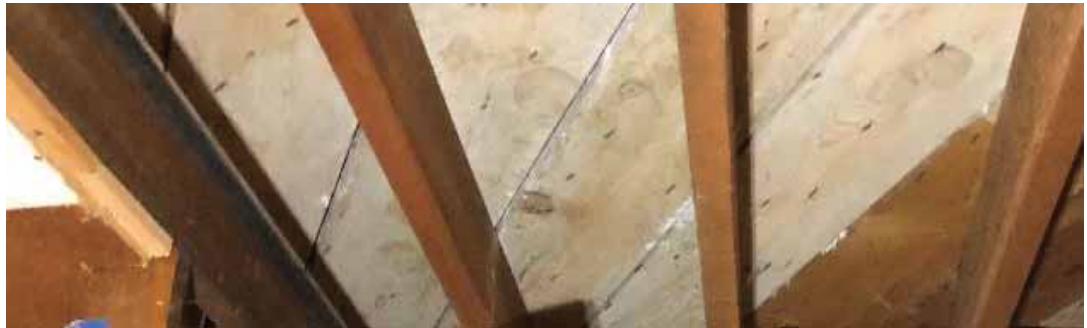
The floor framing above the basement and crawlspace areas is constructed of rough-sawn 2x6 floor joists running east-west. The floor joist spacing varies between 12 inches on-center and 16 inches on-center. The floor joists bear on a 2x sill plate on the original foundation at all perimeter areas. The floor joists are spliced mid-span and supported by a (3) 2x6 dropped header that spans across openings but is otherwise supported continuously by a concrete wall running north-south, roughly centered in the basement and beneath the bearing walls above. Additionally, the floor joists are supported intermittently with beams and columns of various wood materials. These columns bear directly on a concrete slab floor and do not appear to have any footings.

The floor joists support 1x8 skip sheathing with a layer of 1x3 tongue-and-groove hardwood finish floor. Based on historic techniques, it is likely that the skip sheathing boards were used to form the foundation.

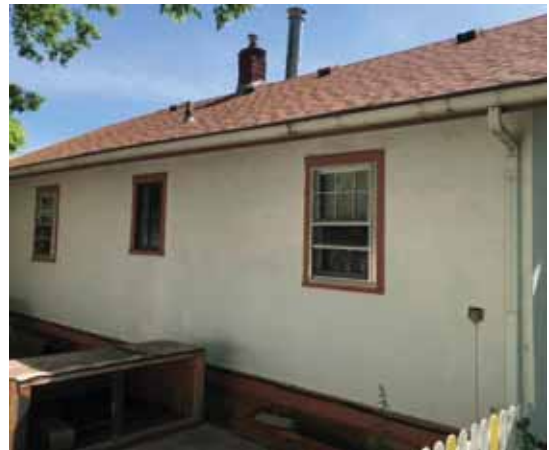
The entirety of the house is clad in painted stucco. The stucco was most likely added ca. 1940's, as was common in the Louisville area. The 1948 Assessor's card image shows the stucco surface. Areas of damaged stucco appear to show a wood siding beneath, which would be consistent with the garage and other historic homes of similar dates around the Louisville area. It is likely that the original wood siding still exists beneath the stucco across the entire house and that the wood siding was attached directly to the wall framing. Additionally, all window trim is nearly flush with the stucco surface, further indicating that the stucco was applied directly over original wood siding. Furthermore, wood siding appeared to be present in the gable ends as seen in the attic.

Since the Garage is clad in Dutch cove siding, it is likely that this is the type of siding underneath the stucco. However, there is also precedent for the stucco being original, given the comparatively late build date of 1936.

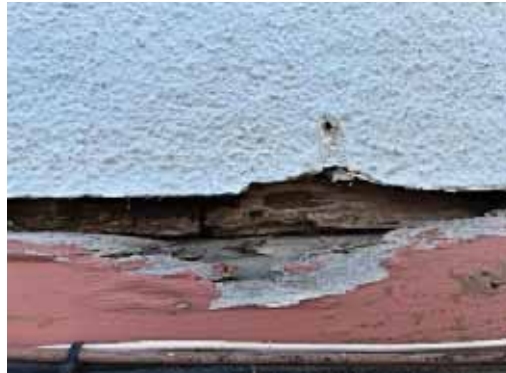
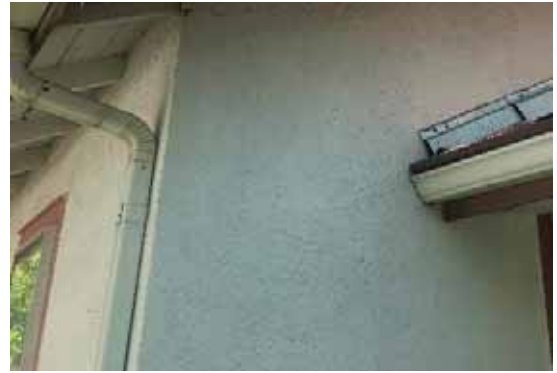
The stucco siding is in fair condition. There are a few water-damaged areas and some areas of cracking, particularly at the base of the stucco.

Investigative deconstruction is recommended in an inconspicuous area to determine if siding exists beneath the stucco cladding. If so, it is recommended that the stucco siding be removed from the entire house. With the removal of the stucco siding, it is likely that an original wood siding will be exposed. Repair, refinish, or replace the original wood siding.

Alternately, if the stucco is determined to be original, repair and restore as necessary.

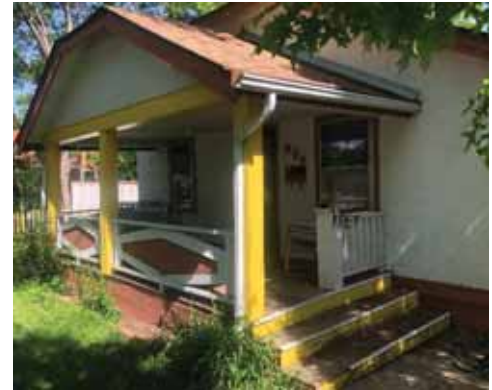
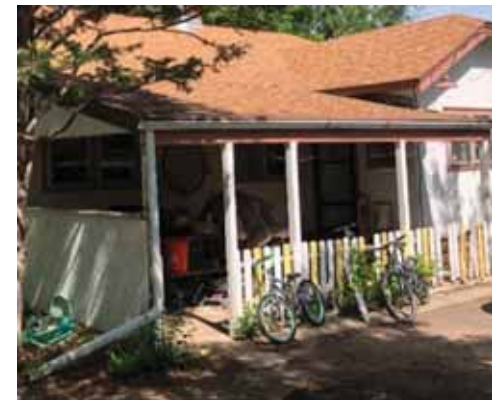
The front porch floor appears to be a single layer of plywood sitting on concrete and is in poor condition with significant water damage. Though the floor slopes, it does not properly drain water that has caused damage over the lifespan of the floor. The original floor was impossible to analyze but is likely concrete formwork. It is possible that the concrete floor structure is in a deteriorated state and that the plywood floor was added as a remedy. The front porch railings are in poor condition with missing moldings and water damage to the wood. It is unknown when the railings were installed, but they are neither original nor stylistically appropriate to the period of significance. The covered front porch ceiling is in poor condition. The ceiling is sagging in the center, possibly caused by poor weight distribution of the roof structure. Some cracking in the stucco ceiling has occurred.

1. Remove the non-original plywood floor to access the original concrete floor and evaluate its condition. The original floor structure should be evaluated and repaired as prescribed by a licensed structural engineer.
2. Replace the current columns with new tapered wood columns and caps based on other historic examples that can be found throughout the Louisville area.
3. Investigative deconstruction should be used to determine the original finish of the porch ceiling. Depending on the results of this analysis, the stucco ceiling should be restored or replaced with beadboard, if originally present.
4. Remove the carport as it is non historic, in poor condition, and poorly constructed. Removing the carport would significantly improve the historic integrity of the home.

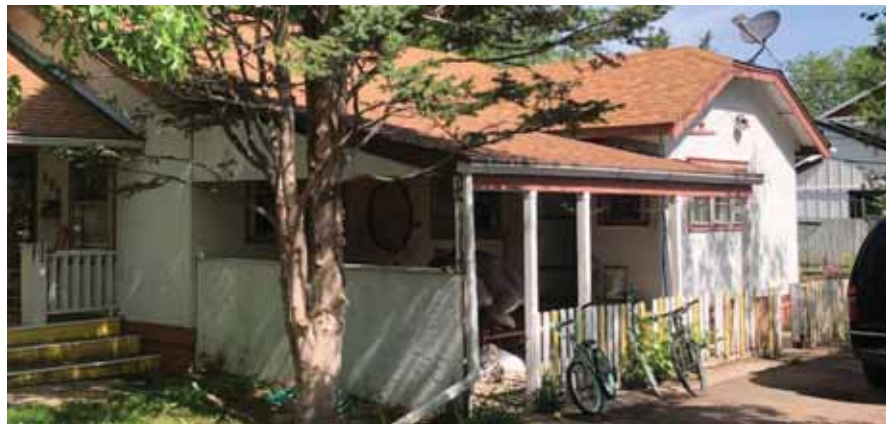
The entire house roof is covered with an asphalt composite shingle roof that was added in 2019, according to building records. This roof was likely replaced due to hail damage, as was common in the Louisville area at this time. The 1948 Boulder County Assessor's card shows that in 1948 the roof material was wood shingles.

The asphalt composition shingle roof is in good condition.

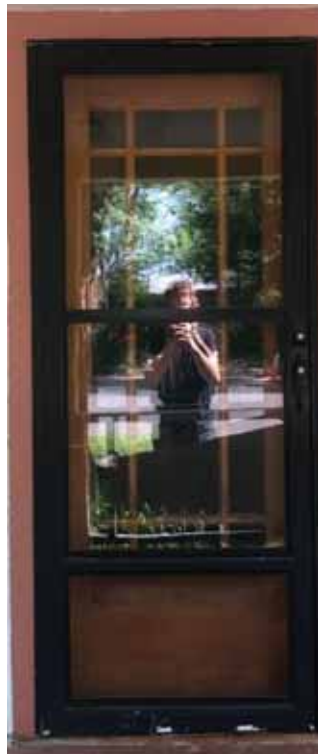
Front door.

The front door is a stained wood door with a three quarter-lite and wood divided lites. Additionally, the front door has an aluminum, full-lite storm door. Although not pictured in the 1948 Boulder County Assessor's card, the door may be original since it fits the frame which maintains consistent trim inside and out. However, based on other nearly identical houses in the Louisville area, the current door may be a replacement for a ¼ lite wood craftsman style door as this is commonly seen on similar buildings.

The two wood doors are in fair condition. Both wood doors work properly and appear to create acceptable seals. The aluminum storm doors are in fair condition and appear to operate properly.

1. Remove the aluminum storm doors from both doors. These doors are in well covered areas that do not need storm doors for weather protection. If screen doors are desired, a minimally framed screen door could be added.
2. Repair and refinish both wood doors.

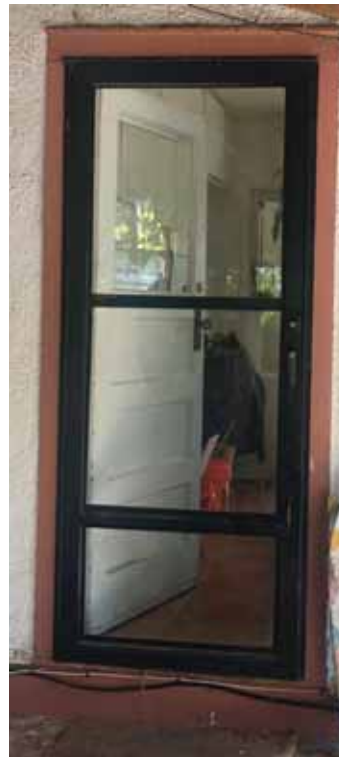
Side door.

The side entrance door to the mudroom is a ¼ -lite painted wood door with three panels below. Although not pictured in 1948, the door again appears to be original based on the consistent trim and construction. The hardware appears to be original. This door also has an aluminum, full-lite storm door.

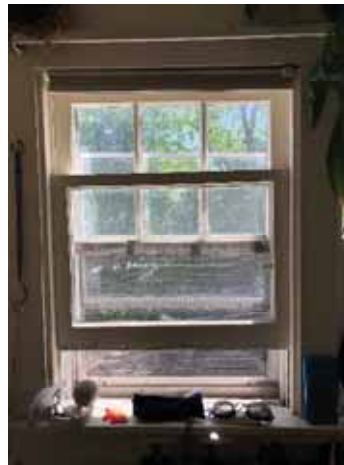
Original wood window as viewed from the interior.

All of the windows are in poor condition, and most do not appear to be fully operable. The storm windows were not tested but also appear to be in poor condition, as several areas are broken and falling apart.

1. Remove the aluminum slider window in the bathroom and replace it with a new unit matching the 1948 image. For durability in a wet area, this window should be constructed of fiberglass, with an exterior appearance that matches the historic windows.
2. Remove the aluminum storm windows from all windows. Consider replacing with new wood storm windows of minimal visual impact. These windows should be removable, with an option for bug screens installed in their place during the warmer months.
3. The historic wood windows should be fully restored. New components will likely need to be used and current energy code should be followed. Ensure that all restored windows are fully operable and match the original window style and operation.

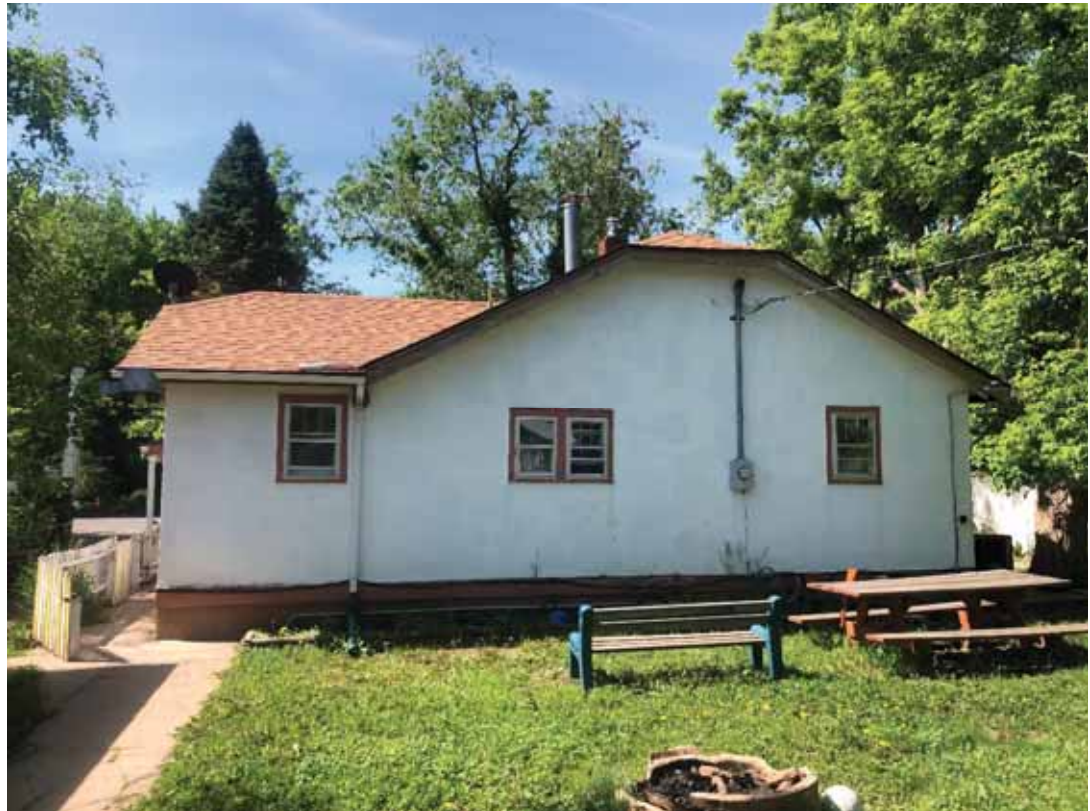
Electrical service to the house is brought in overhead from the alley to the north side of the house. The electrical meter is located on the north exterior of the house with the main breaker panel located in a small closet in the northwest bedroom.

The electrical service was not tested during the site visit but appears to be in working condition. The locations of the electrical panels present difficulties in servicing and they are not properly protected.
