Louisville Highway 42 Revitalization Area
Conditions Survey

Louisville, Colorado

26 May 2005 (Updated June 2006)

Prepared for: Louisville Revitalization Commission and Louisville City Council

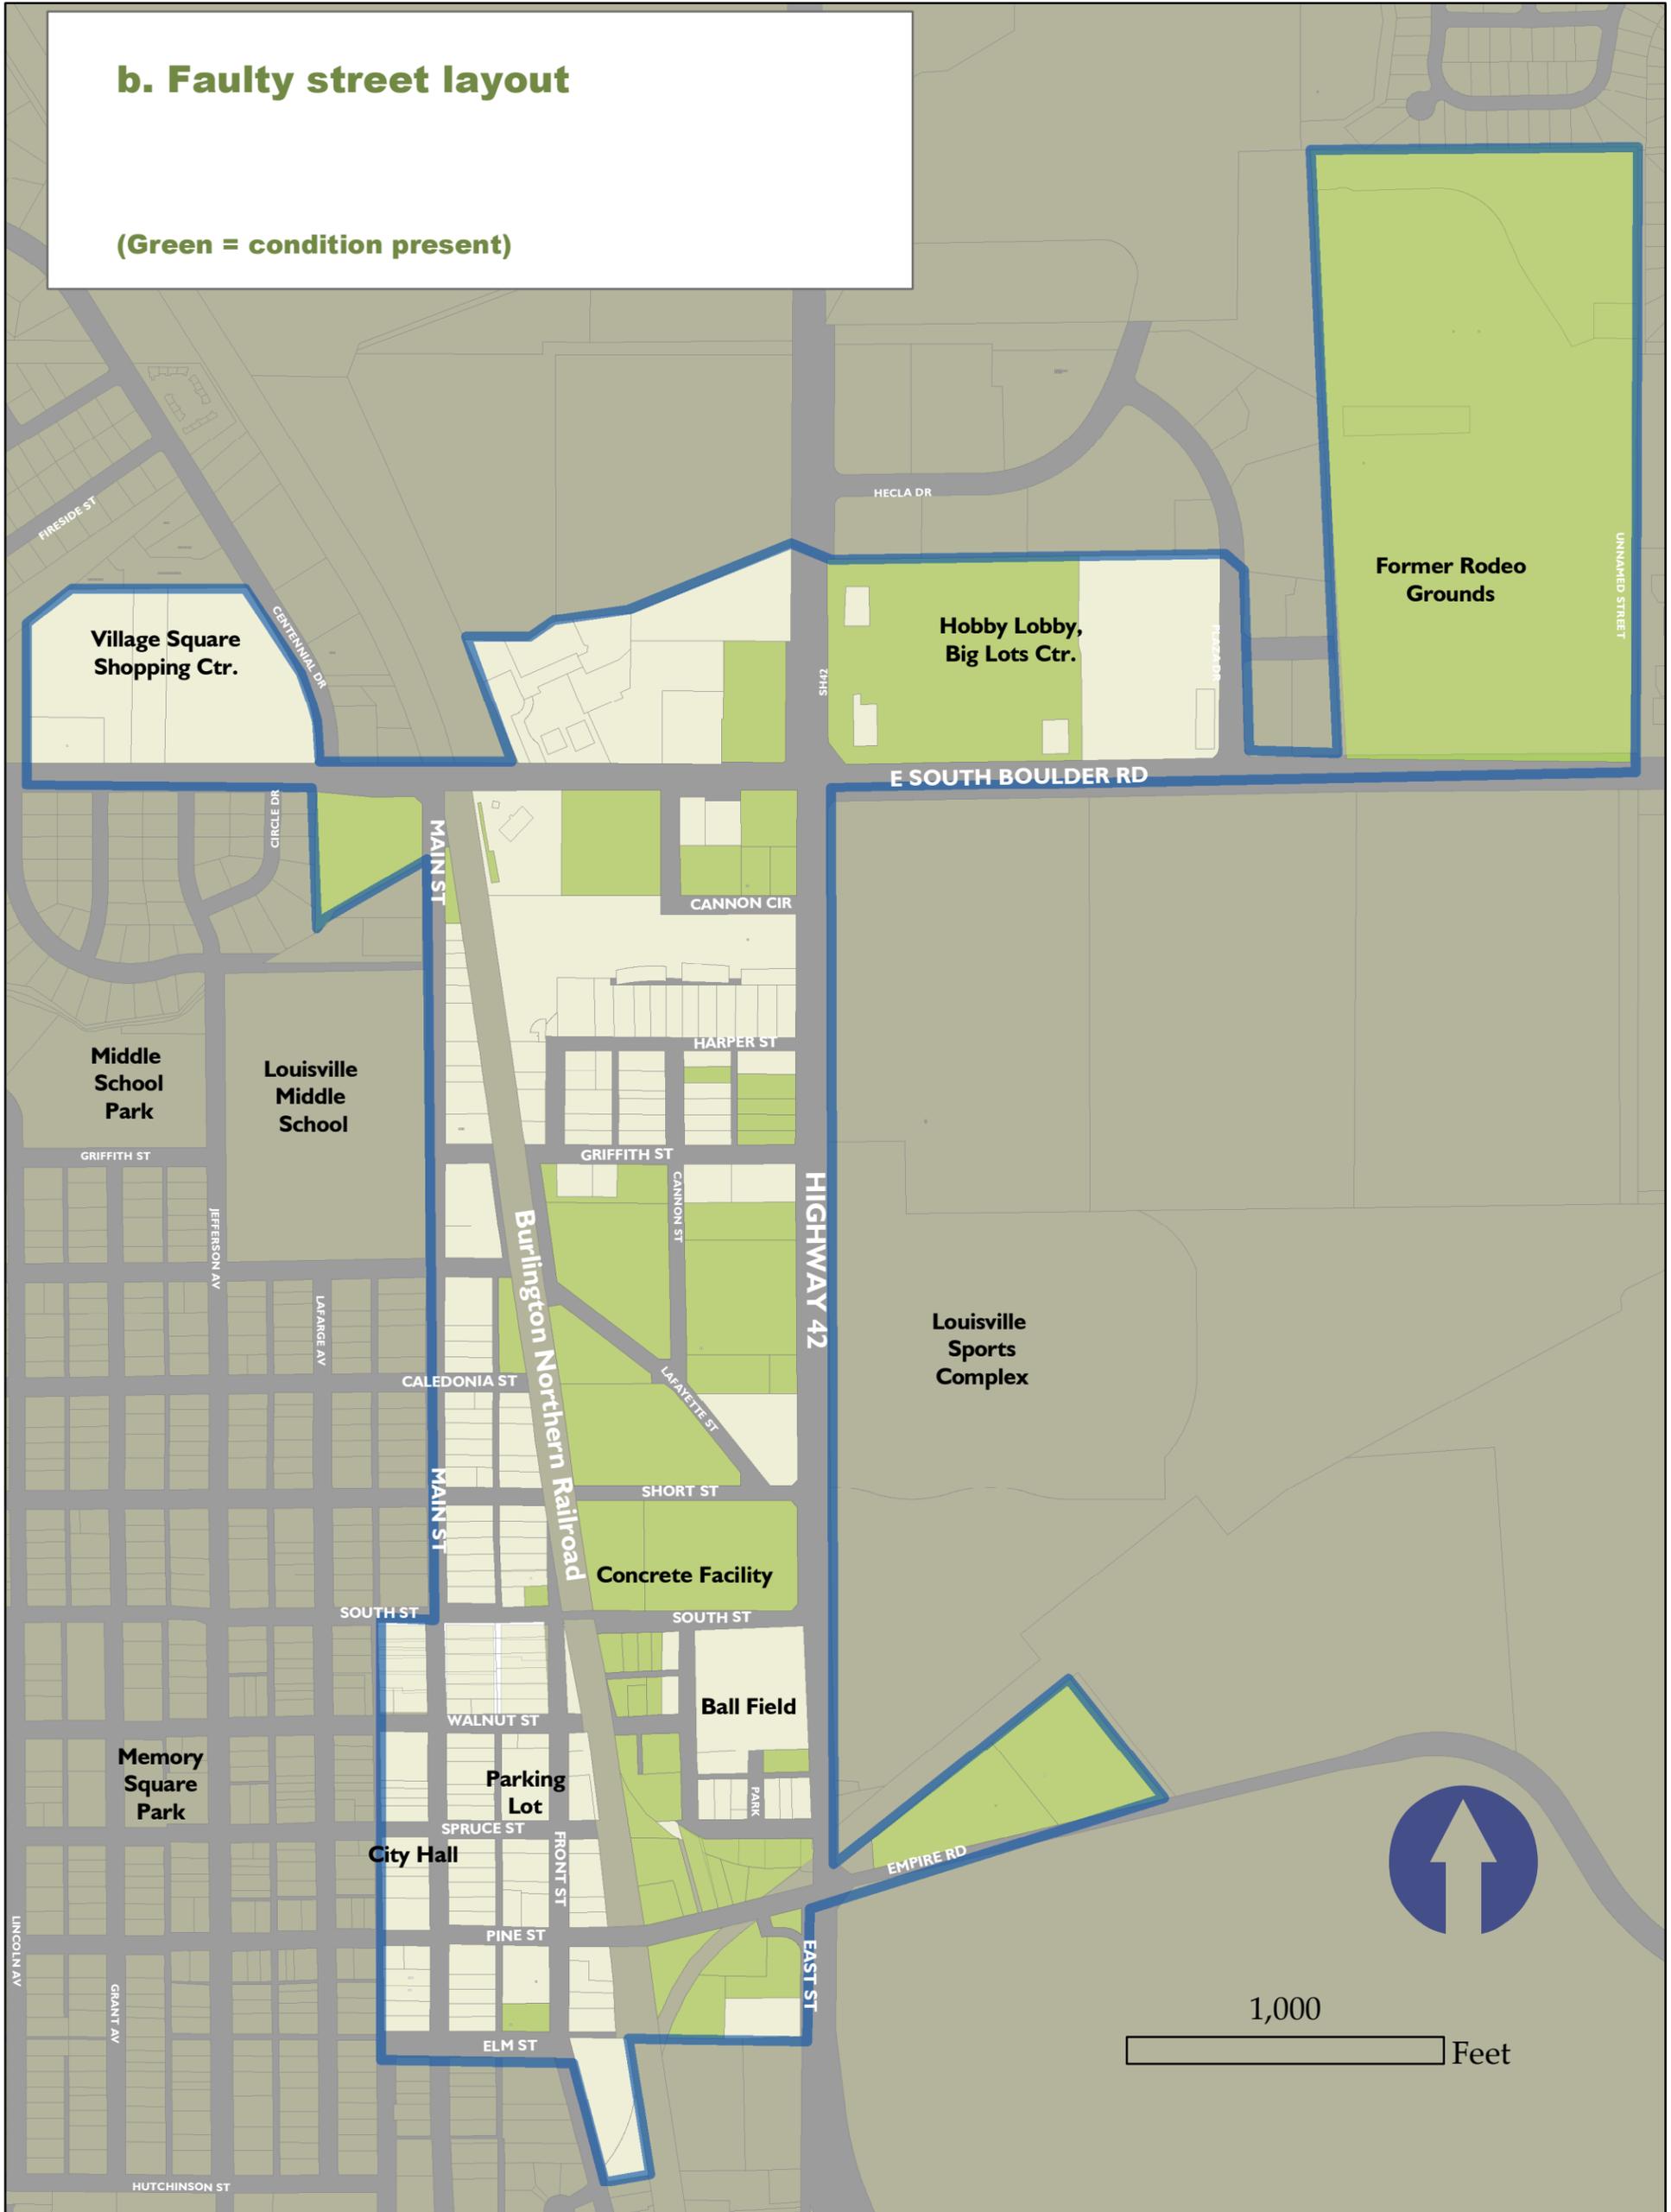
b. Faulty street layout

(b) and (c): Conditions of faulty street and lot layout existed throughout the Study Area. Conditions that did exist concerning defective street and lot layout included problems associated with poor vehicular access and faulty lot layout, shape and size. Parcels in the area of two main intersections were considered to have faulty street layout because of a high incidence of traffic accidents.

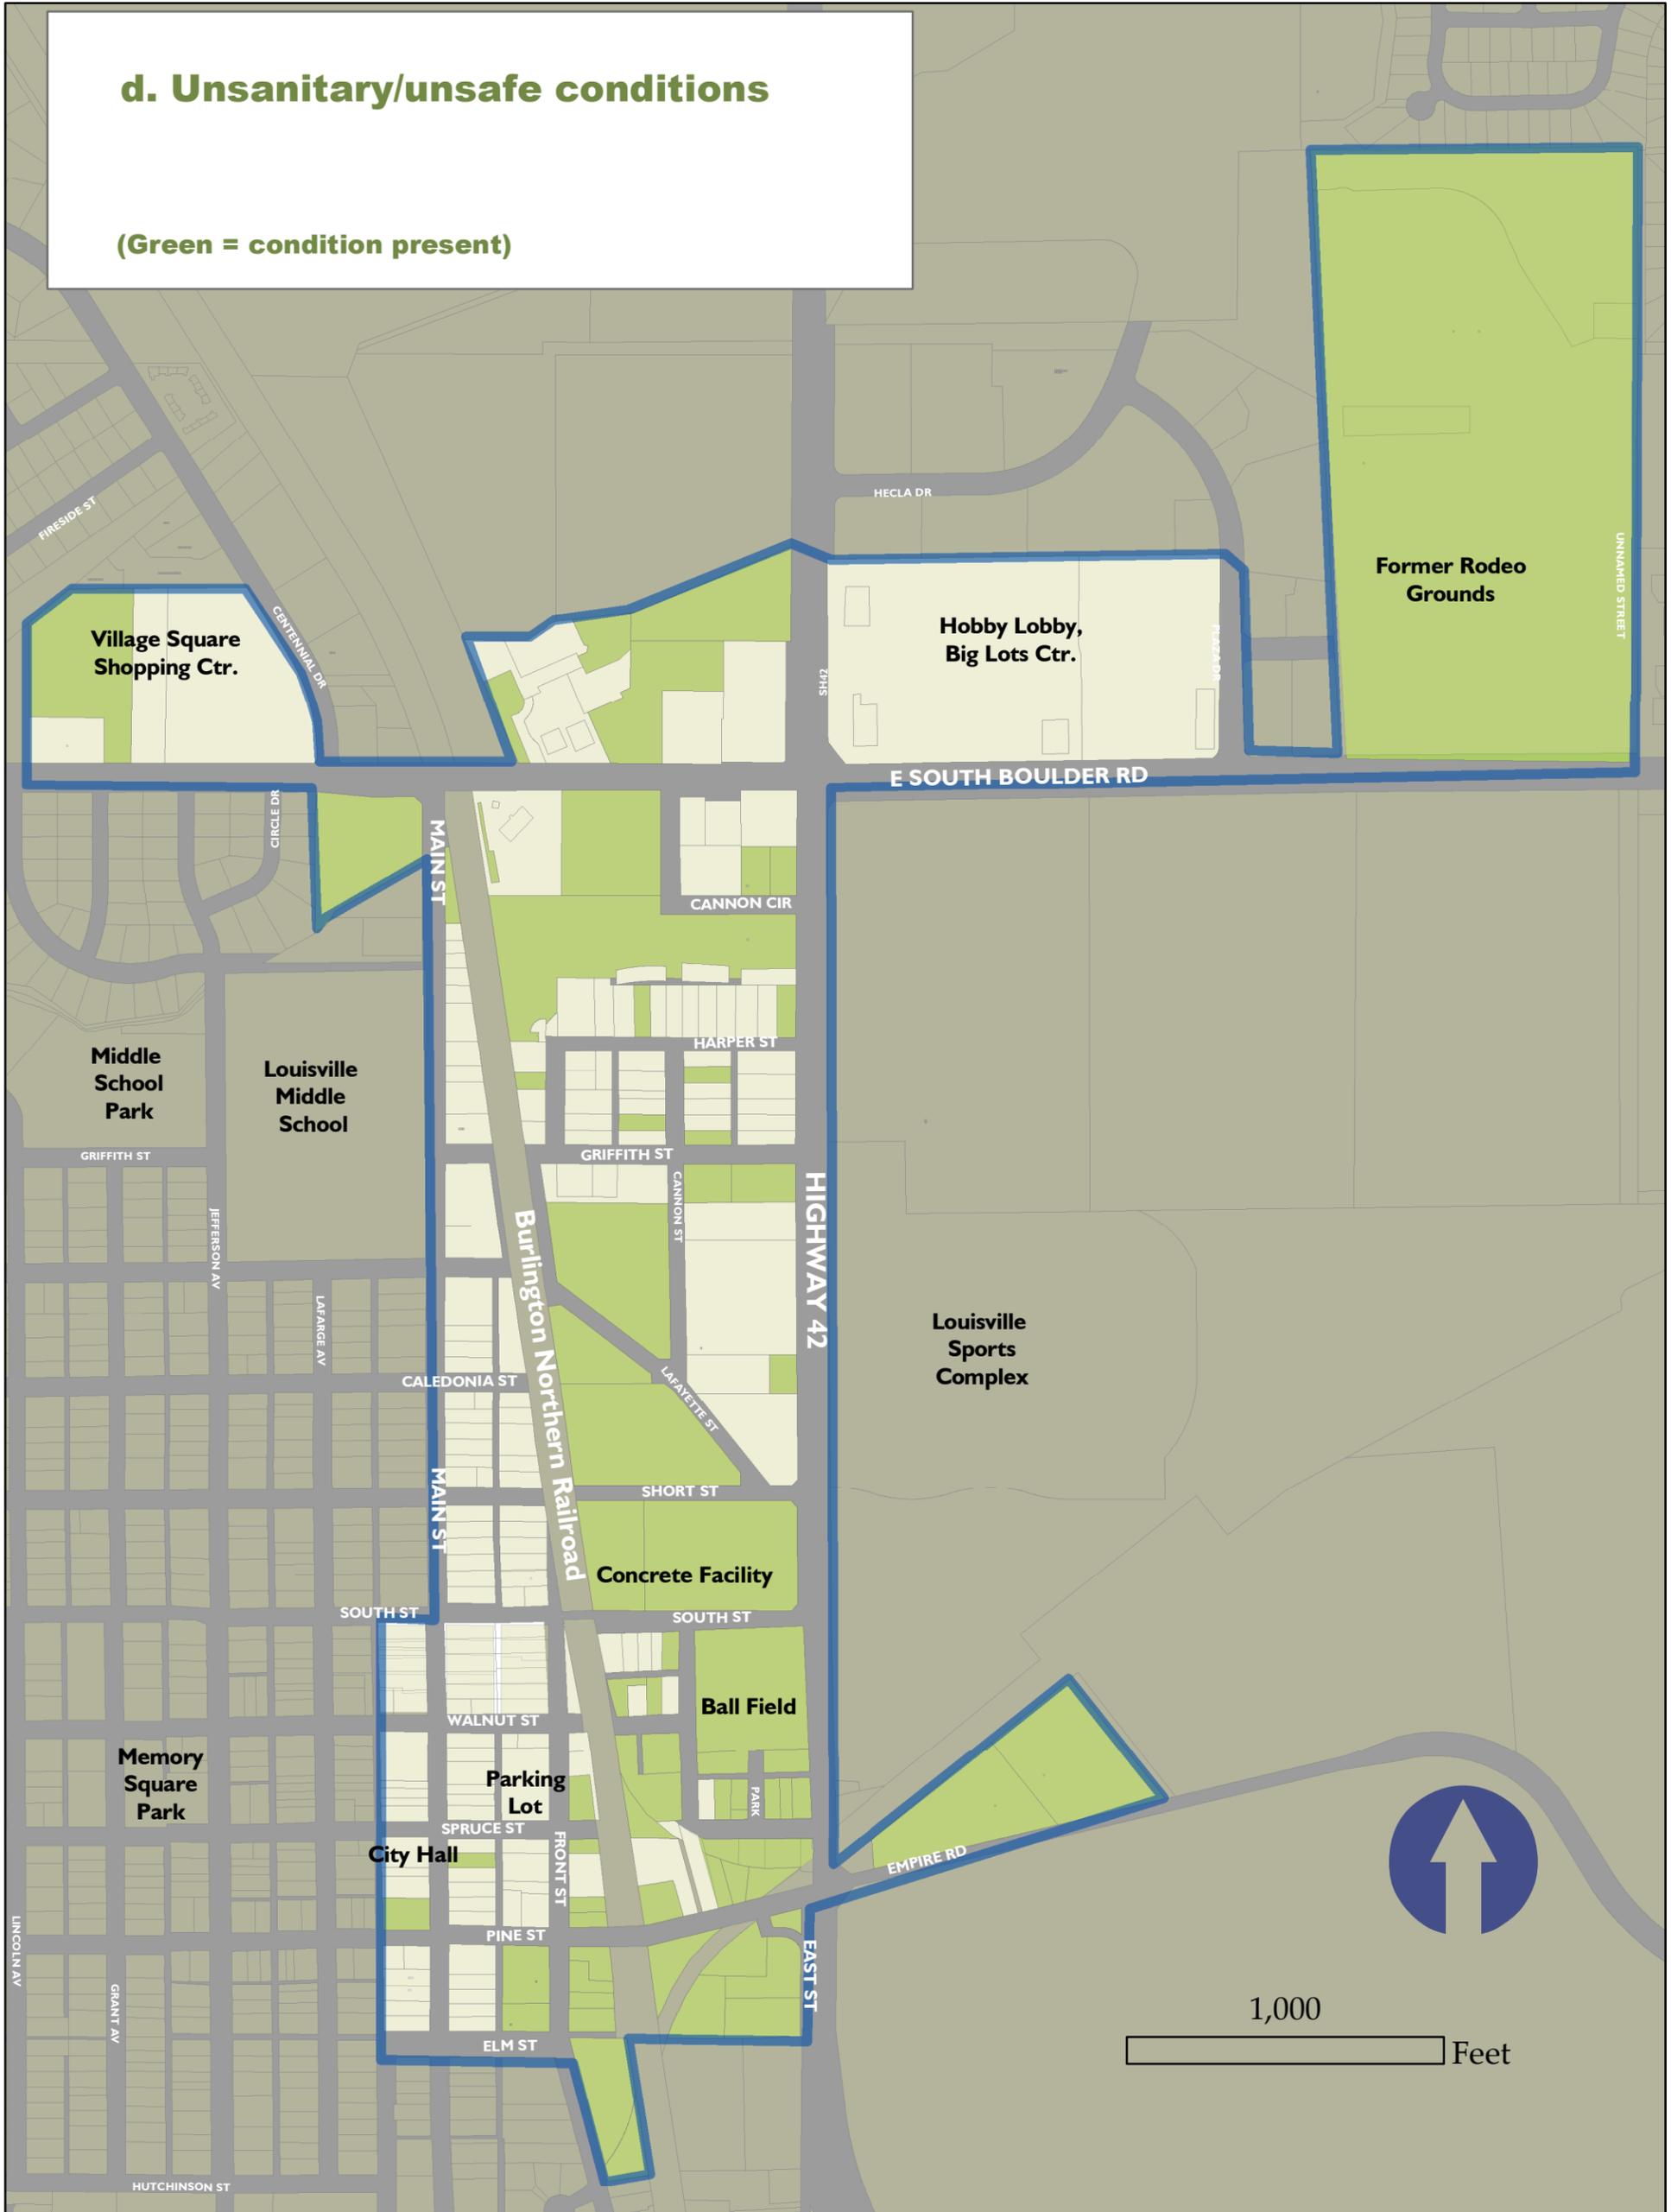
d. Unsanitary/unsafe conditions

(d) and (h): Unsanitary or unsafe conditions and endangerment were prevalent throughout the Study Area. Conditions included poorly lit or unlit areas, curb and gutter deterioration, unscreened trash and equipment, flood hazard and, in a few cases, abandoned vehicles.

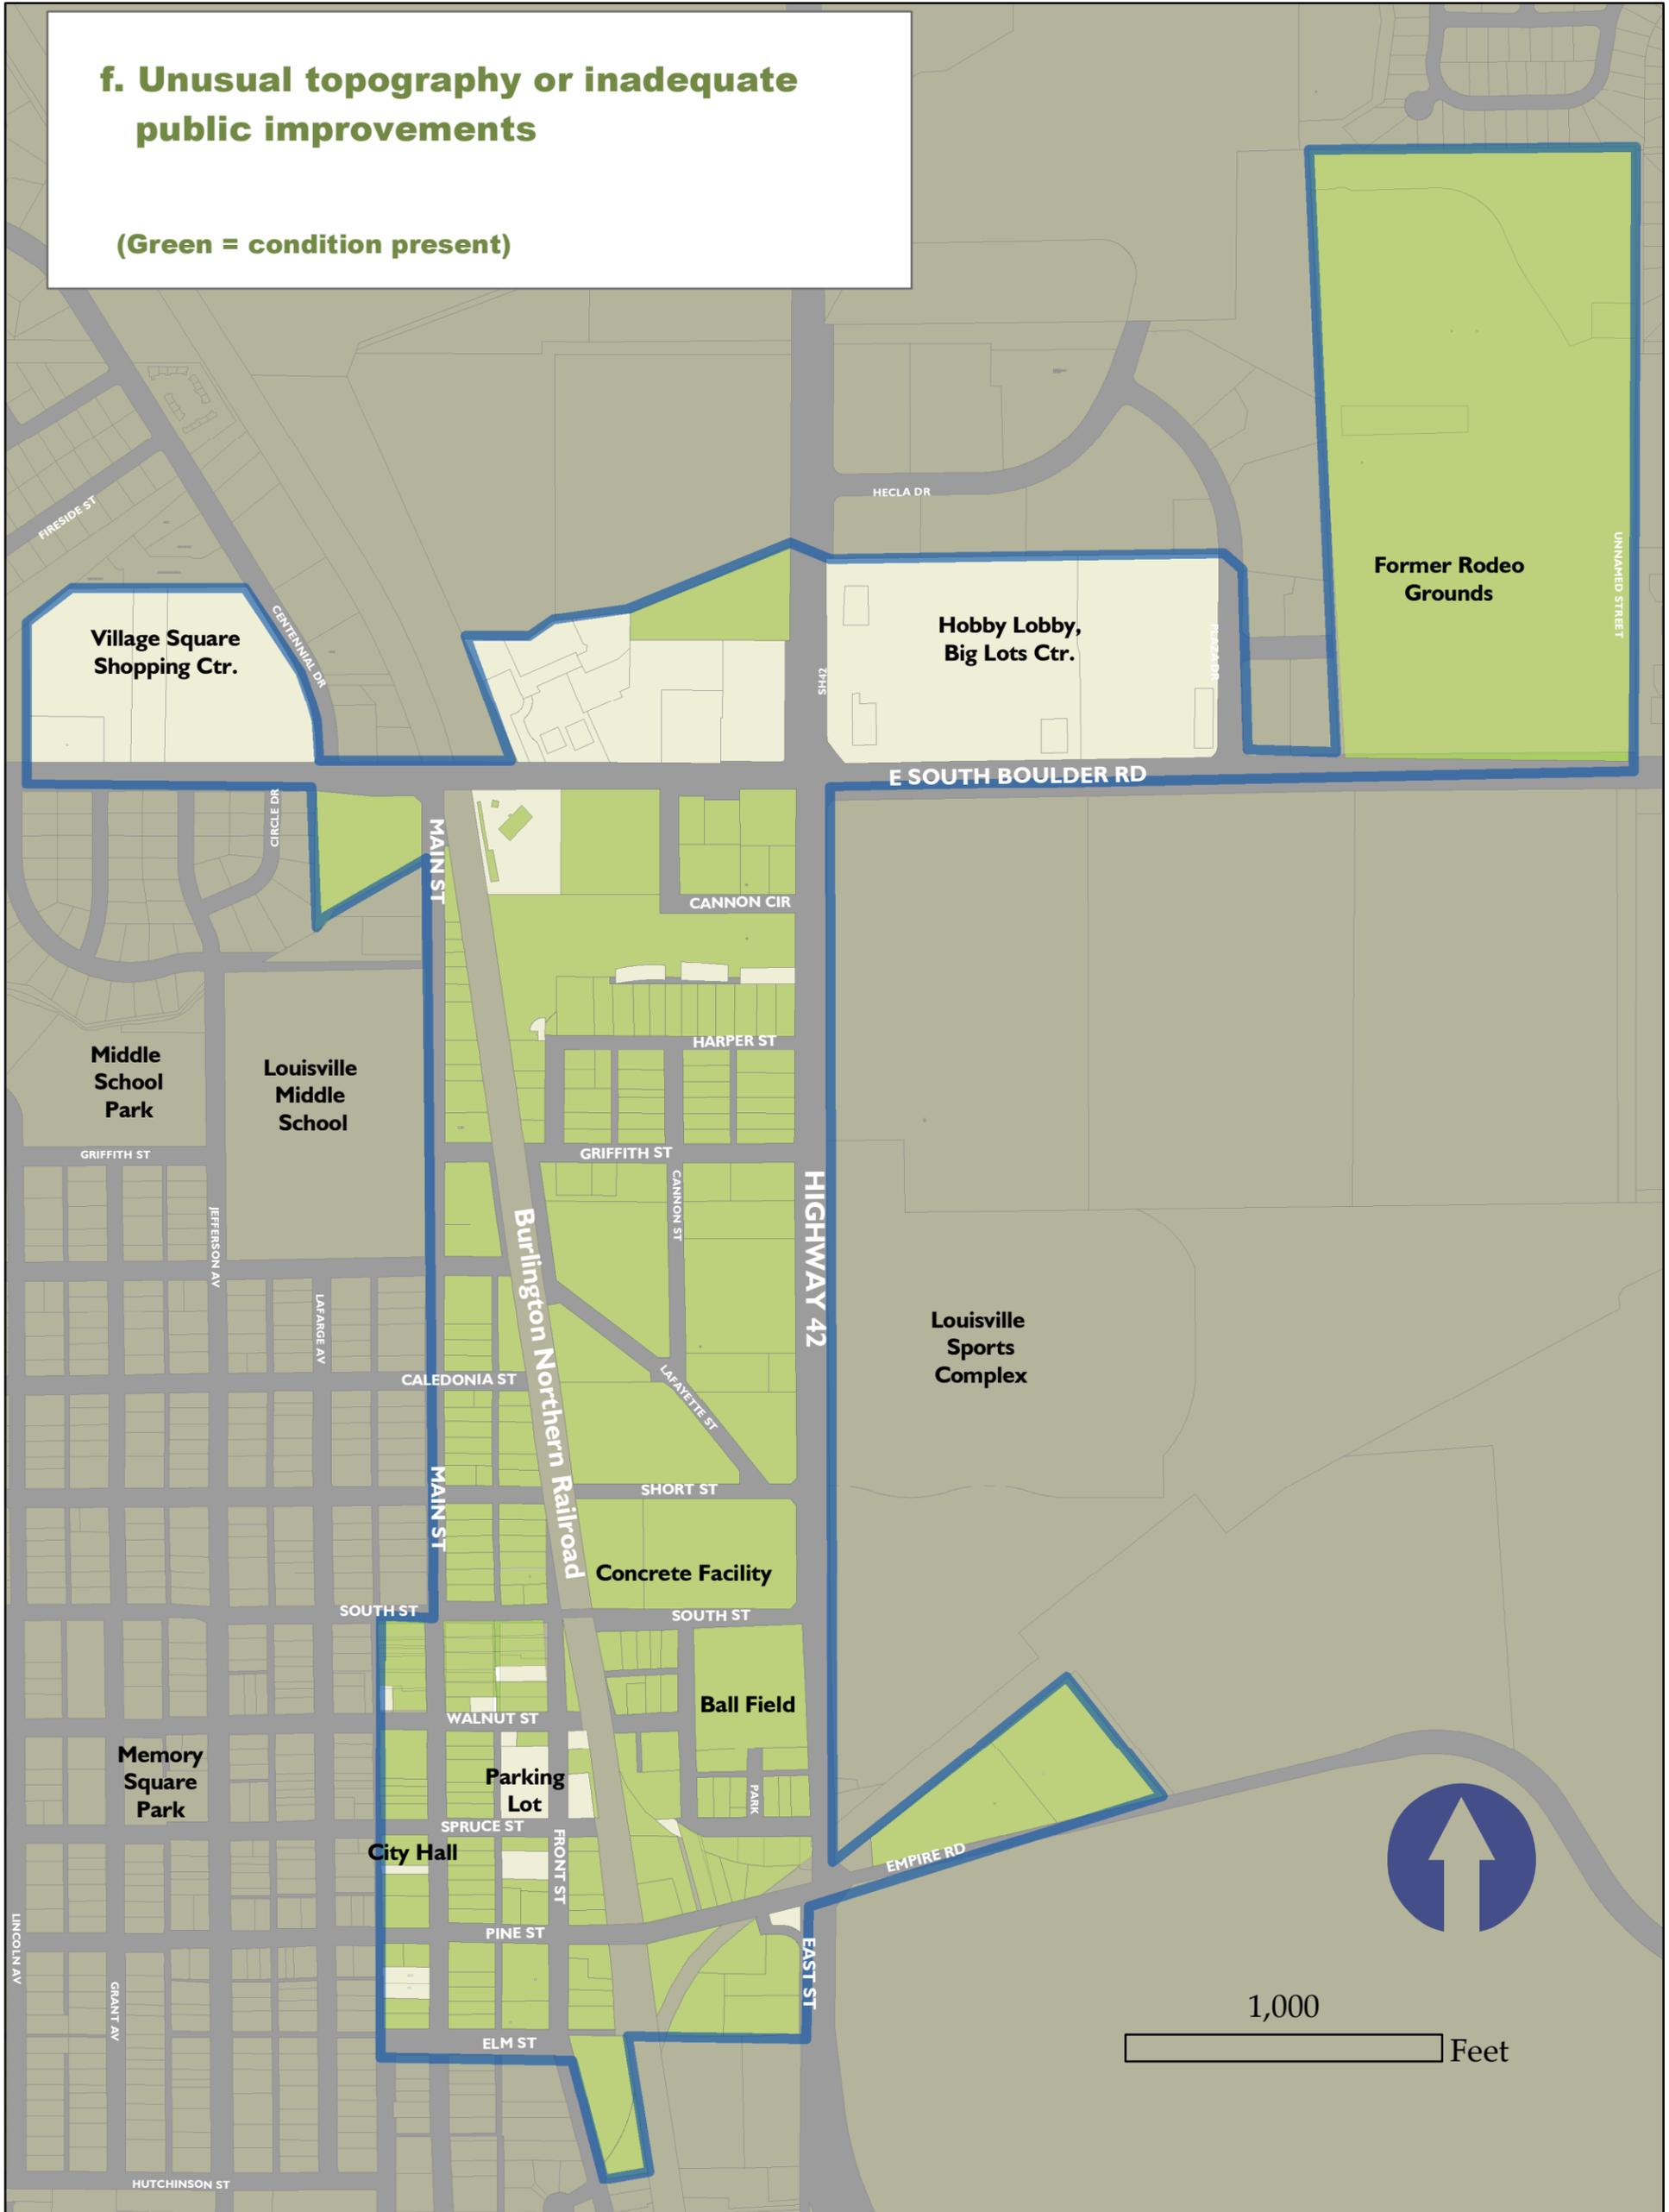
f. Unusual topography or inadequate public improvements

(f): *Unusual topography and inadequate public improvements* were evident throughout the Study Area. Inadequate public improvements was nearly universal within the Study Area due to street pavement (and shoulder) deterioration, a lack of sidewalks, curb & gutter and, most prevalent, overhead utilities.
